# FIRE RISK APPRAISAL EXTERNAL WALLS

## BOULTON HOUSE

Spon Lane  
Tipton  
B70 6BJ

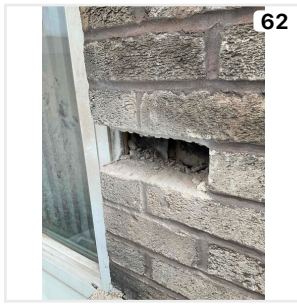
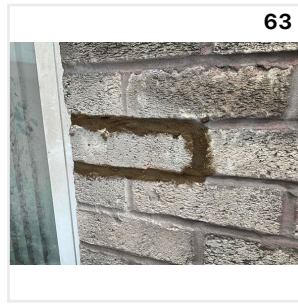
## Inspection Photos

# Inspection: X4FKDR

Elevation • Location  
South Elevation • Compartment Floor and Wall Junction Interface

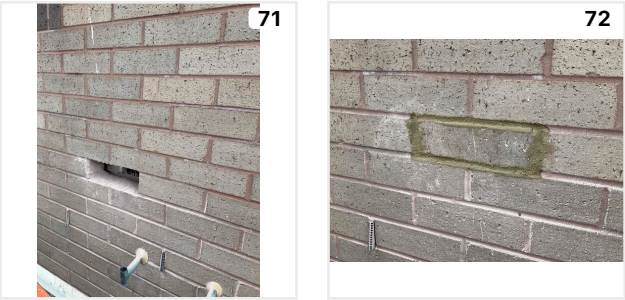
# Inspection Photos

# Inspection: 5LCNJB

Elevation • Location  
South Elevation • Penetration
