# FIRE RISK APPRAISAL EXTERNAL WALLS

## FARLEY STREET

West Brom  
DY4 7LA

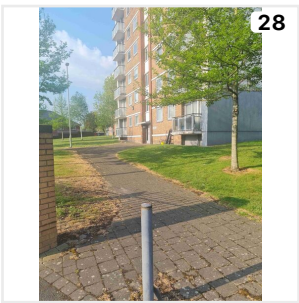
## Inspection Photos

Unable to access, mewt cannot drive on grass and wheels will be on grass. Unable to use ladder due to ledge

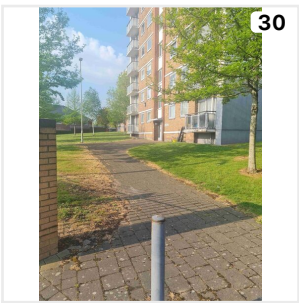
## Inspection Photos

Unable to access, mewt cannot drive on grass and wheels will be on grass. Unable to use ladder due to ledge
