# FIRE RISK APPRAISAL EXTERNAL WALLS

## OAK COURT

Acacia Avenue  
West Bromwich  
WS5 4BN

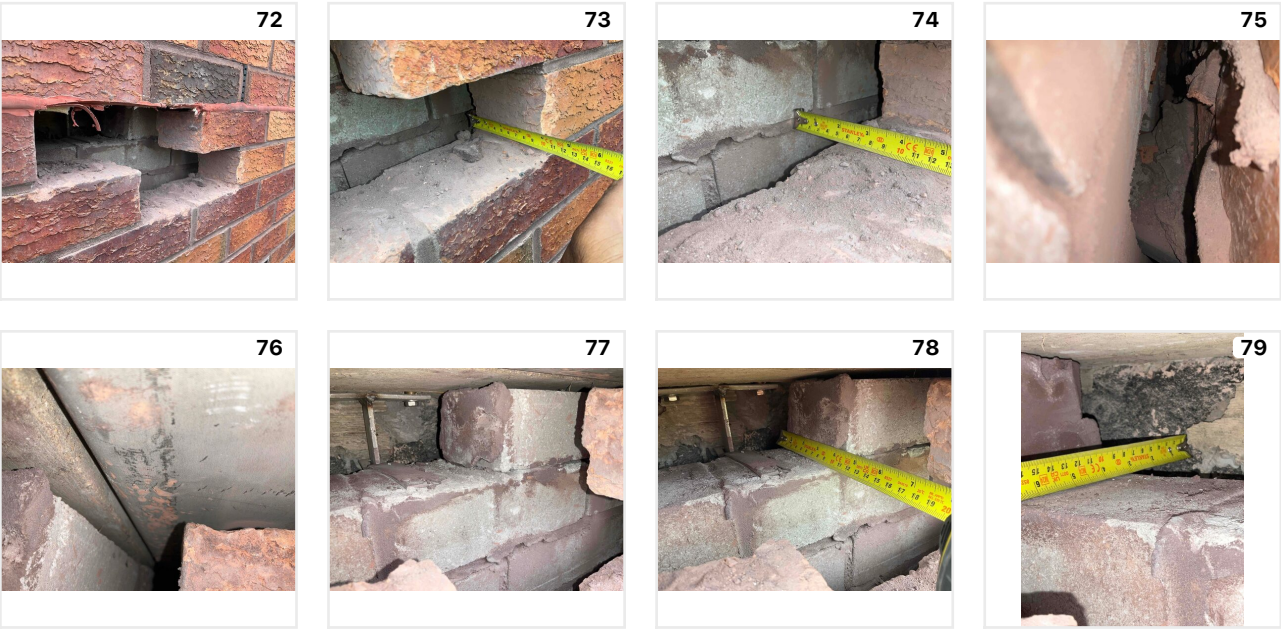
Build-up Photos

Reinforced concrete

**Conclusion:** This wall system is comprised of a rendered cement dash coat applied to a double-leaf masonry system that was observed to contain no insulation. The outer leaf of masonry was identified to be a rendered cement dash coat applied to 102mm brickwork, and the inner leaf was observed to be a 100mm blockwork.
