**FIRNTEC**  
BUILDING COMPLIANCE

# FIRE RISK APPRAISAL EXTERNAL WALLS

## PAGET HOUSE

Sedgeley Road East  
Tipton  
DY4 7TU

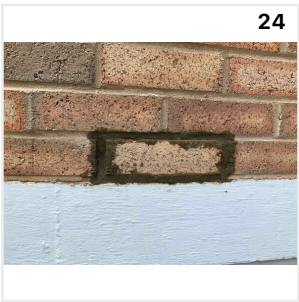
# Inspection Photos

Elevation • Location  
East Elevation • Aperture Opening

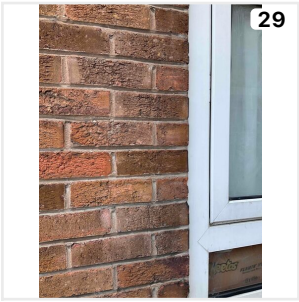
# Inspection Photos

Elevation • Location  
East Elevation • Compartment Floor and Wall Junction Interface

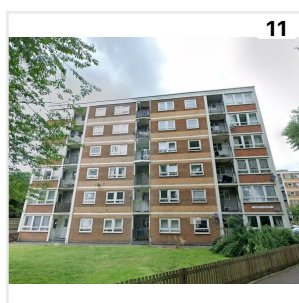
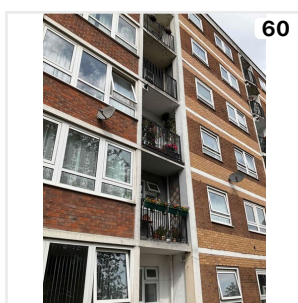
## Photos

These inset balconies are configured in a stacked vertical configuration on the front elevation of the building. They are formed of non-combustible materials. The steel balustrade and handrail, and the concrete soffit, will not contribute to the spread of fire across the external surface of the building. The soffit will also act to disrupt the mechanism for vertical fire spread between the balconies.
