Fire Risk Assessment

13-18
Peartree Lane,
Cradley Heath,
B64 6EH

Date Completed: 10/11/2025

Current Risk Rating = Tolerable

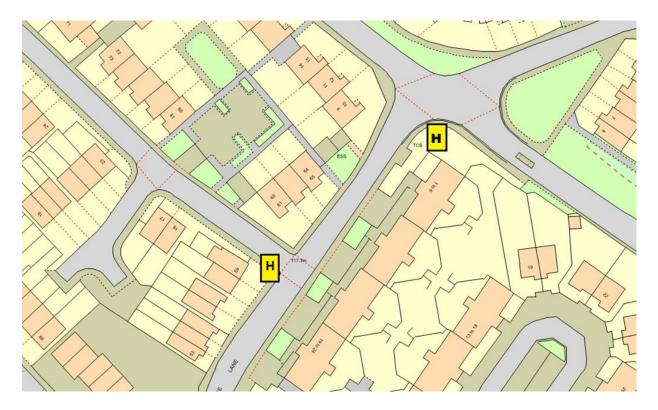
- 1) There is no firefighting equipment on this premises.
- 2) Nearest fire hydrant is indicated within the attached plan
