Fire Risk Assessment

1-3

**Walker Avenue,
Tividale,
B69 1NP**

Current Risk Rating = Tolerable

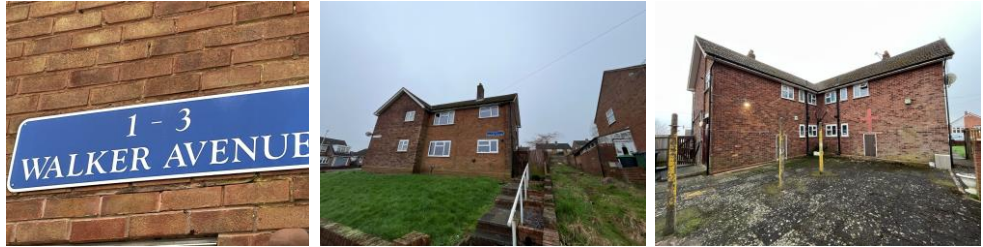
The low-rise, two-storey block (inclusive of the ground floor) was constructed in 1965 using traditional brick cavity and concrete construction. The roofs are pitched and finished with concrete interlocking tiles. Around the roof line uPVC fascia boards are fitted with asbestos cement underclocking soffit boards.

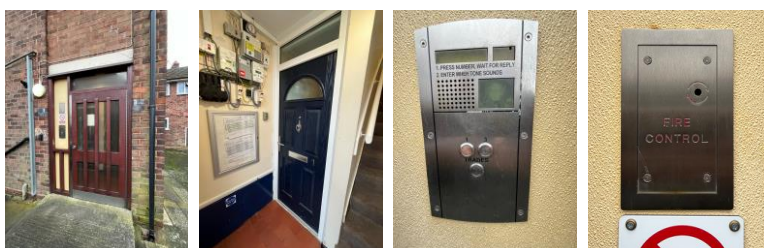
Next to the front entrance door and within the rear courtyard there is a safety/security light installed.

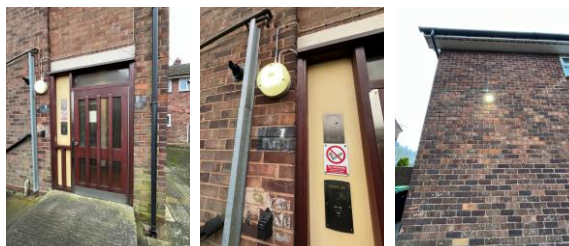
At the rear of the premises the courtyard is shared with 96-96a Tower Road. Within the building at the rear there is a small storage cupboard which is kept locked with a residential key.

Bins are situated at the side of the building close to the entrance/exit of the block. Email sent to housing manager & caretaker to look at relocating these away from door, possibly within the courtyard 16/03/2026

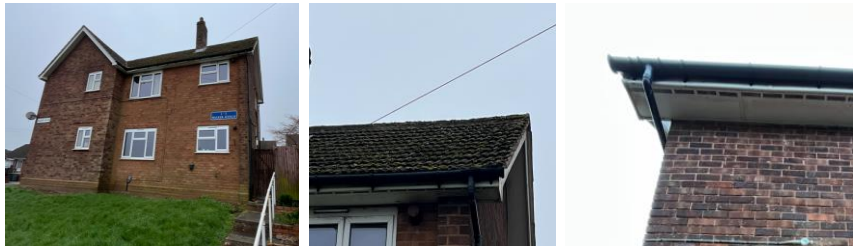
- 1) The external surface of the building is predominantly brick structure with uPVC fascia and asbestos cement undercloaking soffits. The roof is pitched and fitted with concrete interlocking roof tiles on the roof.

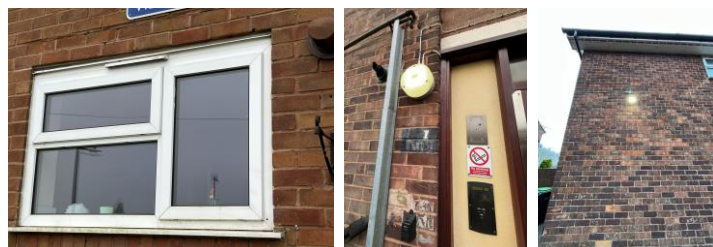
- 2) uPVC double-glazed units have been installed in each flat and one at the top of the communal stairway. A security/safety light is fitted above the entrance door and one at the rear of the property. The entrance door is timber construction with glazed panels.

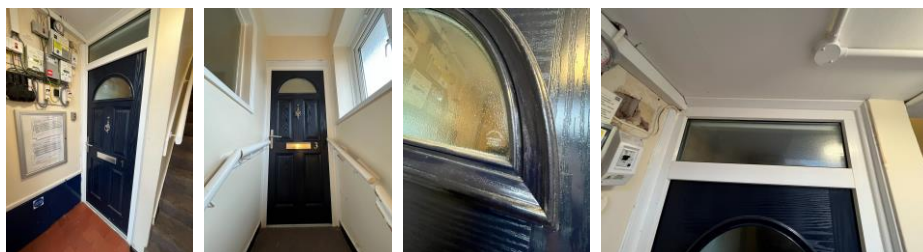
- 4) None of the corridors that form part of the means of escape are dead ends.
- 5) Two flats are located within the block, and both entrance doors are glazed FD30s fire doors. The glazing within each door displays the EN14449 kitemark, which confirms that it is laminated glass or laminated safety glass, including types that can be fire-resistant.

However, the glazed panel above the door does not display any kitemark or stamp, so its fire-resistant properties cannot be verified.

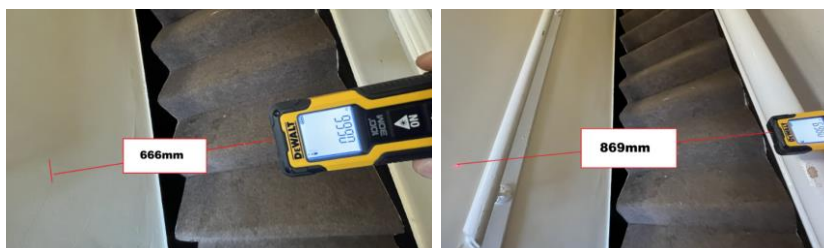
9) Within this block the first floor is accessed via a single staircase that provides a means of escape for flat 3 and has a width of a minimum of 666mm between the handrails, and 869mm wall to wall.

- 10) The flooring and stairway within this property are concrete construction, the stairway has a carpet covering fitted.

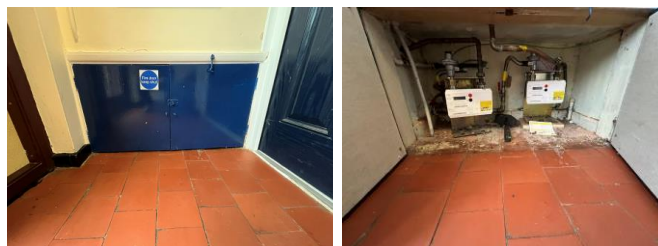
- 14) Gas meters: Gas meters are located outside flat 1 within the communal area of the block and are housed in small service cupboards that lack ventilation to the exterior. The cupboard doors are not fire-rated, are not fitted with appropriate lockable hardware to prevent unauthorised access, and do not display signage indicating the presence of gas installations (see Section 10/6), it is also recommended that an upgrade is carried out during future refurbishment works See Section 10.

“Fire Door – Keep Shut” also “Gas meter” signage is affixed to the current door. Refer to Section 12 for the associated action.

6) Gas Service Cupboard located ground floor outside flat 1: Gas meters should be relocated to an external position to remove the hazard from the communal escape route. SMBC Gas team have contacted Cadent to explore this option 19/01/2026; however, Cadent have confirmed that they have no planned works to relocate the meters within the next 12 months. As such, interim measures are required, including:

- a) As no future works are planned with Cadent to relocate the gas meters, suitable permanent ventilation must be provided. This should include the installation of a ventilation brick or equivalent arrangement to ensure compliant airflow to the exterior of the property. This has been added to recommendations to be undertaken at a future refurb date. Meeting held on the 23/02/2026 concluded that the service cupboards would be surveyed for the addition of ventilation being added to the outside of the building.

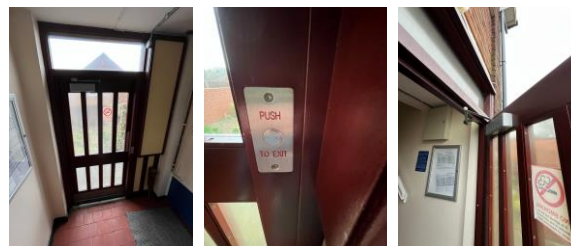
17) The final exit doors are fitted with a push button to egress the building and are also fitted with automatic closing devices that are checked on a regular basis by caretaking teams as part of their checks. Defective closing devices are replaced either by the Caretaking Team(s) or the in-house repairs team(s). The final exit doors have door entry systems installed. These systems are designed to fail safe i.e. door unlocked in the event of a power failure. This prevents residents being locked in or out of the building.

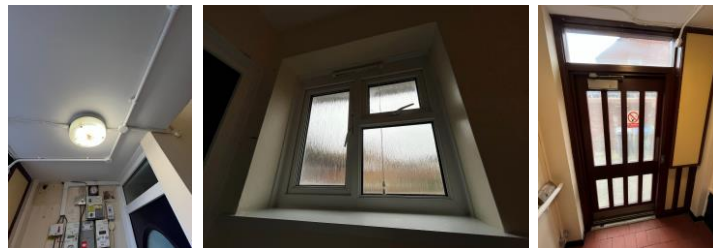
19) No emergency lighting is provided to communal landings and stairs. Adequate lighting comes from standard lighting also from the door and window areas.

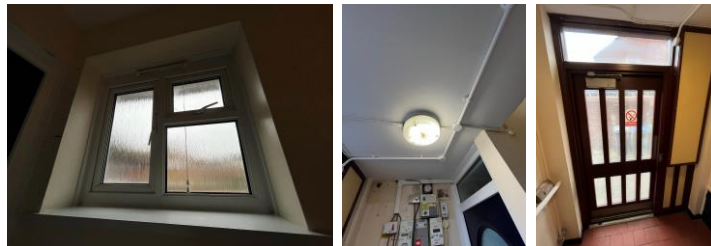
- 1) The premise is not fitted with emergency lighting.
- 2) There is standard lighting within the communal area also a landing window and final exit door to assist in lighting the communal areas from outside.

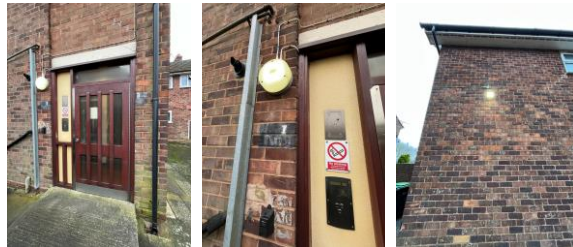
- 1) Regular checks are undertaken by Caretakers / Cleaning Team(s) 365 days per year which helps reduce the risk of arson.
- 2) Access to the premises is by means of a key, fob that only residents or using a fire fighters drop key.
- 3) Perimeter is covered by external lighting

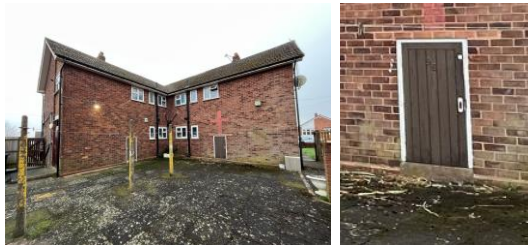
- 1) Residents instructed not to bring L.P.G cylinders into block.
- 2) The tenancy conditions, Section 7 – Condition 5.6 stipulates “If you live in a flat or maisonette, you, people living with you and any visitors to your property must not keep or use paraffin oil, petrol, bottled gas appliances or any other explosive, FLAMMABLE or dangerous material in the property. This restriction also applies to any storage facility situated in or attached to the block, which has been provided for your use.”
- 3) Residents should not store flammable liquids or gas cylinders on site.
- 4) No Flammable liquids stored on site by Caretakers / Cleaners.
- 5) There is one storage cupboard in the rear courtyard, which is built within the building and is locked by a tenant only key.

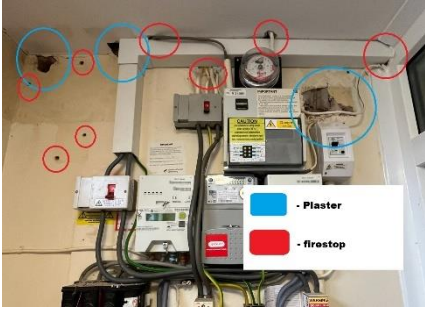
7/16	O/S Flat 1: Defects and unsealed openings were identified in the vicinity of the electrical consumer units and associated switchgear. Plastering and silicone filling required.

16) Defects and unsealed openings were identified in the vicinity of the electrical consumer units and associated switchgear. These breaches in the fabric of the building compromise the required fire-resisting construction and must be remedied. Their locations are indicated on the accompanying diagram and will be recorded within the action plan of this Fire Risk Assessment for corrective works.

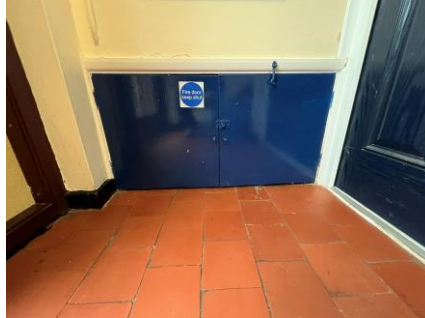
P2	Within 1-3 months Fire Rapid Response	
10/6a	Gas Service Cupboard OS flat 1: Fit a suitable sliding bolt latch to the external side of the door to assist in keeping the doors secure
