Fire Risk Assessment

Broome House

**Beaconview Road, West Bromwich,
B71 3PN**

Date Completed: 13/02/2025

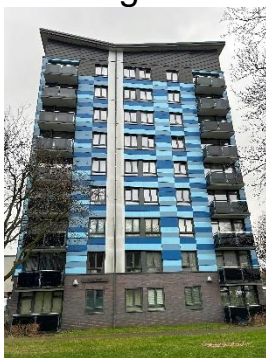
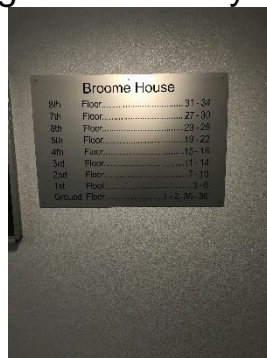
The High-rise residential block was constructed in 1964 out of a concrete brick construction and was last refurbished in 2015 with the installation of an external wall system. The block consists of 9 stories inclusive of the ground floor with each floor containing 4 number dwellings coming off a lift lobby.

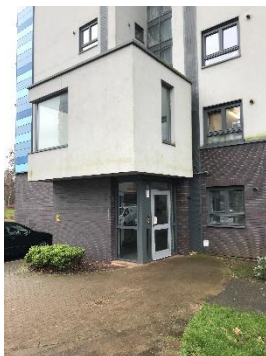
(Left side MAP)

There is an entrance/ exit to the left side elevation to the block with an additional entrance/exit to the right-side elevation (from the main road). The left side elevations entrance acts as the main access point to the block.

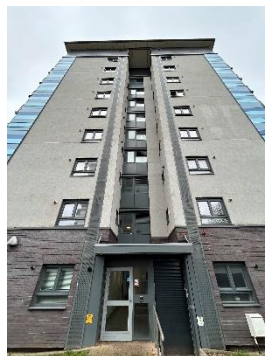
(Right side)

Both entrances utilise fob access in order to gain entry to the block with the main access point also having access to a firefighters override system in the form of a drop latch switch. Both entry/exit points use a push to exit button.

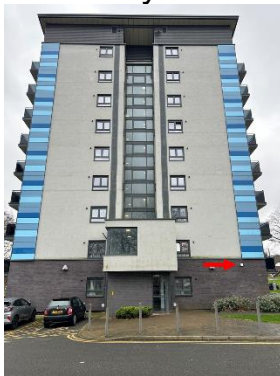
The block has a single protected staircase serving all floors of the block with floor identification numbers / Wayfinding signage on the wall of each floor. The staircase is protected using nominal 44mm FD30s doors with combined intumescent and smoke seals.

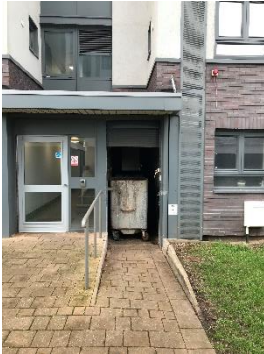
The bin chute leads to a bin store located on the ground floor accessed externally on the right side elevation near the additional entrance/exit to the block.

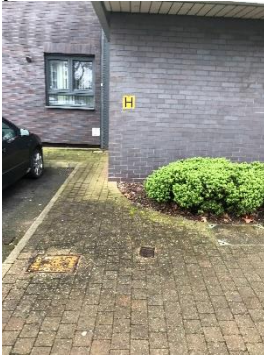
There is a dry riser that serves all floors of the block with a dry riser inlet cupboard located on the ground floor door that is adequately signed and secured, each floor of the block contains a dry riser protected via nominal 44mm FD30s doors with combined intumescent strip and smoke seals.

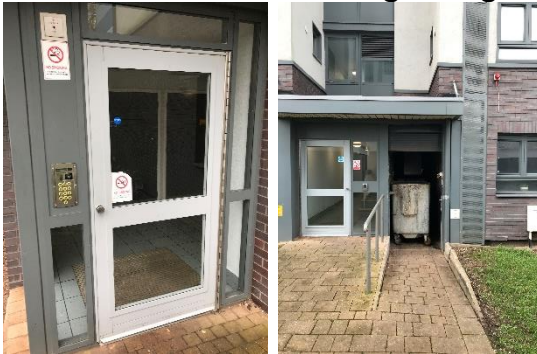
- 2) The external wall system/ façade consists of 6% Brick, 33% Render, 35% Glass (windows and balconies), 7% Brick slips. 19% High pressure laminate.
- 3) Front and rear entrance/exit is constructed of an aluminium door and frame with double glazing.

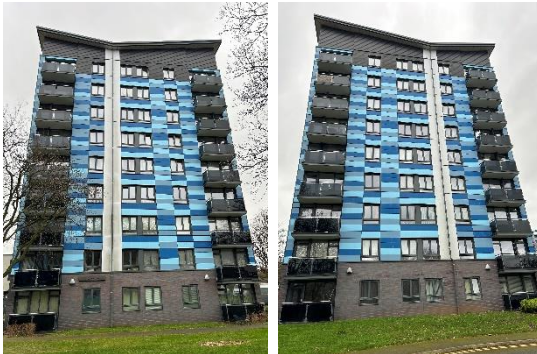
- 4) Residents have balcony access coming from their individual flats on the front and rear elevations of the block.

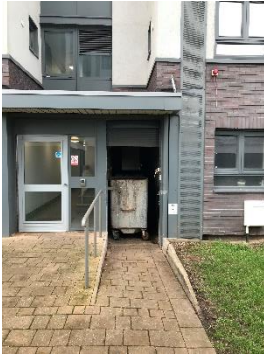
- 6) It was noted that some balconies may have had combustible materials in the form of hanging washing this is deemed acceptable risk due to the likelihood of a fire starting in this area being low and combined with the temporary nature of the activity.

Under no circumstances should netting or screening be attached to balconies as they can support fire spread across the external of the building. Other options should be explored

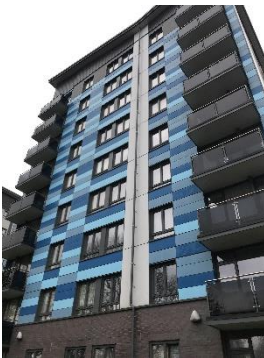
- 7) Aluminium faced timber composite windows to resident's flat windows/balcony doors and communal windows.

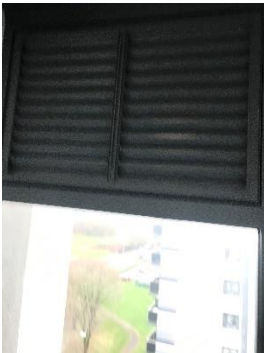
- 8) Natural ventilation to the bin chutes in the form of louvre vents.

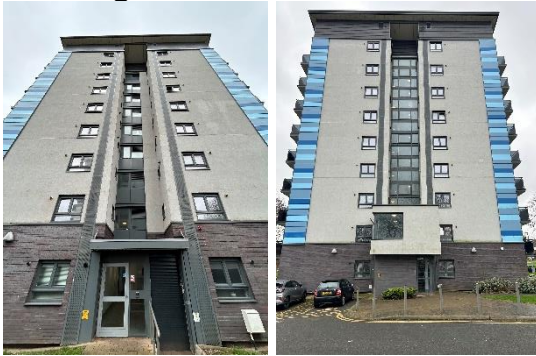
- 9) AOV's serving all floors run along the side elevations of the building.

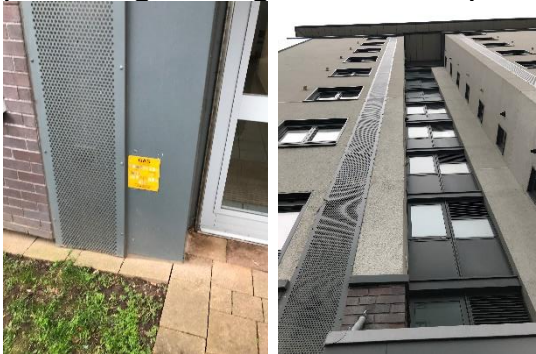
- 10) Gas was noted to be external, secured behind corrugated panelling, with gas isolation points located on the orientation plan.

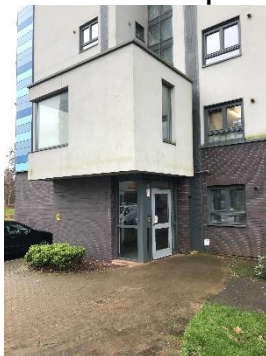
- 11) There is a communal viewing Pod on the first floor above the Main access point to the block.

- 15) Communal viewing pod located on the first floor secured with a 44mm timber nominal door with intumescent strips, cold smoke seals and vision panels is secured with a type 34 mortice lock that residents have access to this room remains relatively sterile with the cleaners cupboard also being within this area noted the cleaners cupboard is missing the addition of combined intumescent strips and smoke seals as this is a nominal door and the area being regularly accessed by cleaning / caretaking teams the element of risk is tolerable however with future improvements to the block it should be considered that this door is upgraded to a FD30s.

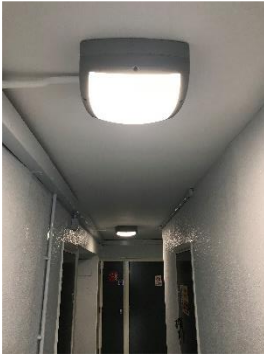
- 1) The premises has a sufficient emergency lighting in accordance with BS 5266 and has test points strategically located.
- 2) The units are provided to the communal landings, stairs and lift motor room.

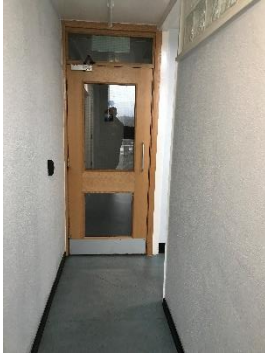
- 8) A variety of methods / materials have been used to achieve fire-stopping including Rockwool, fire rated sponge and intumescent pillows.
- 9) Individual flat doors are a combination of 44mm nominal FD30s composite/timber fire door construction.
- 10) Corridors / staircases are protected by use of FD30s fire doors with vision panels.

Some nominal communal landing doors are starting to show signs of general wear and tear due to age. Consideration should be given to upgrade with certified FD30s door sets & combination frames with future improvement works.

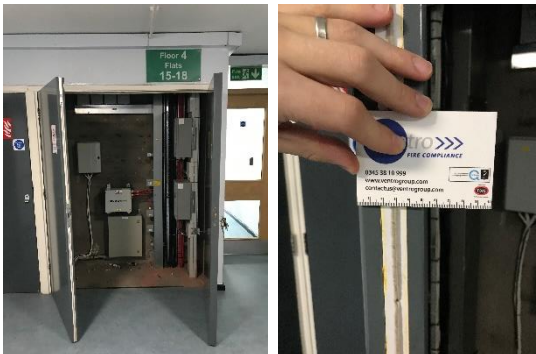
- 11) Cupboard doors within the communal areas such as residents meter cupboards/ electrical risers' cupboards are nominal 54mm FD60 timber fire door sets with intumescent strips, cold smoke seals.

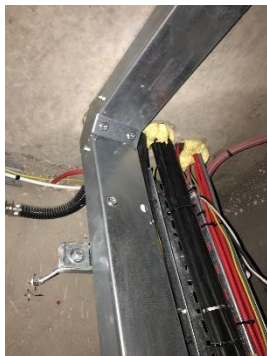
- 12) The use of expanding foam was present within the communal cupboards around cabling as part of the fire stopping knowing that intumescent pads and a concrete slab is present and this foam is only used as an enhancement it is deemed tolerable. This should be enhanced as part of future works to the building and replaced with intumescent mastic to improve fire stopping

Noted the use of expanding foam was present within the communal cupboards around cabling as part of the fire stopping knowing that intumecent pads and a concrete slabe is present and this foam is only used as a enhancment it is deemed tolerable. This should be enhanced as part of future works to the building and replaced with intumecent mastic to imporve fire stopping.

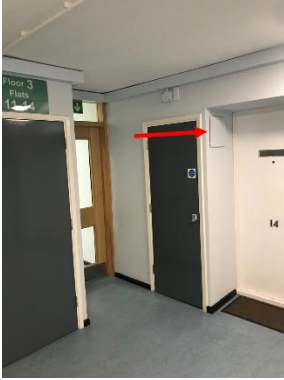
- 13) Access panels to stop taps are fixed to masonry and bedded on Intumescent material.

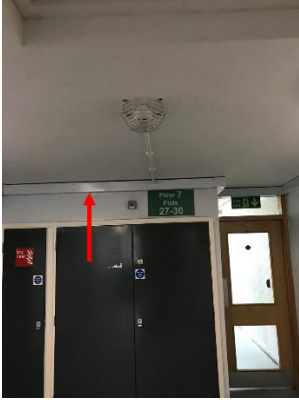
- 14) It was noted that metal trunking had been utilised to house cabling in communal areas

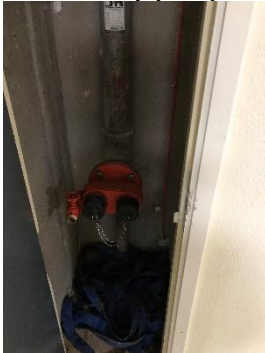
- 1) The dry riser inlet cupboard is located in the ground floor lift lobby and is appropriately signed

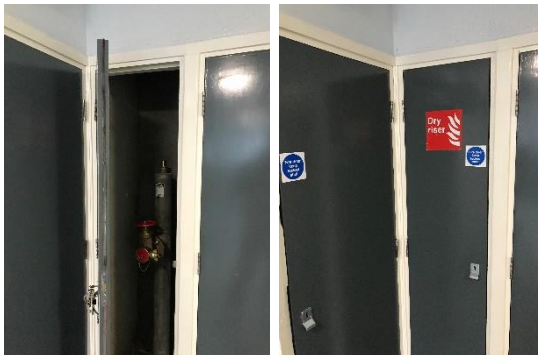
- 2) The riser outlets are available on each floor lobby (ground – 8th) these are protected via nominal 44mm 30-minute fire doors secured by suited 54 key & mortice locks.

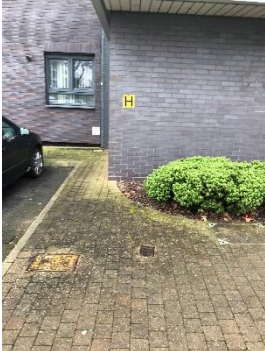
- 7) Fire hydrant can be located at the side elevation nearest the main access point to the building

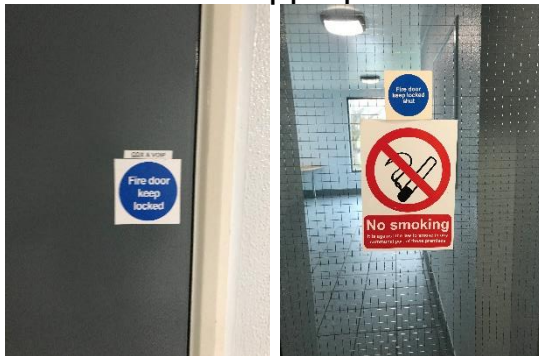
- 1) All fire doors display “Fire Door Keep Shut” or “Fire Door Keep Locked where appropriate.

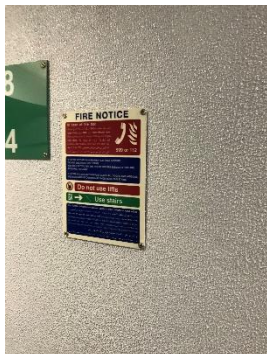
- 2) Fire Action Notices are displayed throughout the building.

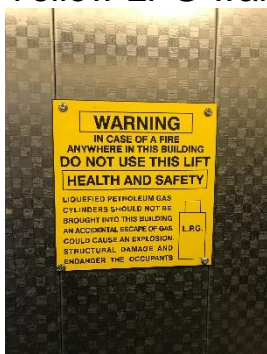
- 3) Yellow LPG warning signs are displayed within the lift car.

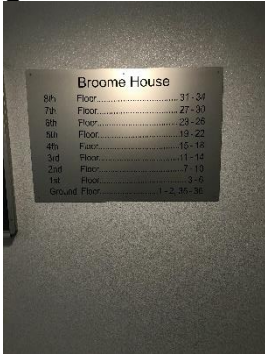
- 4) Signage depicting the floor location of each flat is fitted to the ground floor lobby wall.

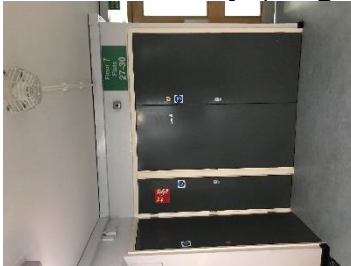
- 5) Wayfinding Signage depicting floor level and flat numbers are fitted to the wall adjacent to lift. They meet the requirements set out in the Fire Safety (England) Regulations 2022

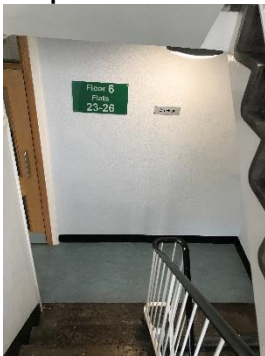
- 6) Wayfinding Signage depicting floor level and flat numbers are fitted to wall of each floor on the communal staircase(s). They meet the requirements set out in the Fire Safety (England) Regulations 2022

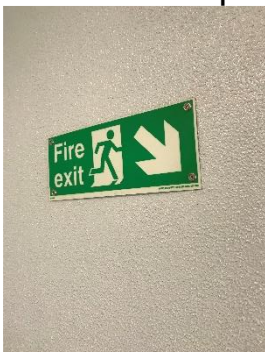
- 7) The fire escape routes use directional fire signage

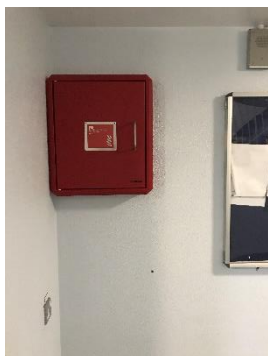
- 8) Premise information box is signed appropriately

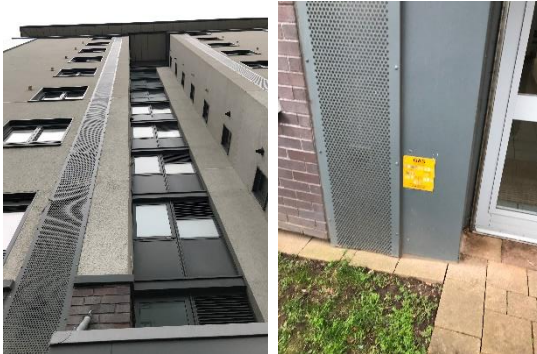
by the in-house Gas Team. **Gas supplies are external secured behind corrugated panels.**

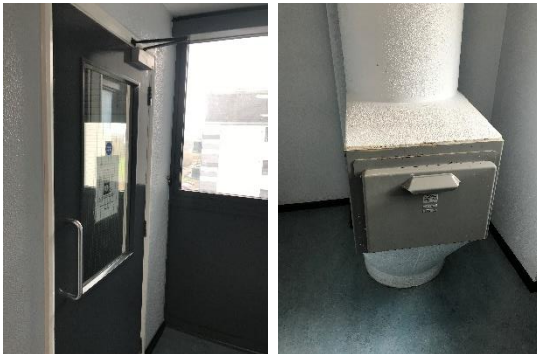
- 1) There is a regular Cleaning Service to the premises.
- 2) Refuse hoppers are accessed on each floor secured behind its own dedicated nominal 44mm 30-minute door with combined intumescent and cold smoke seals.

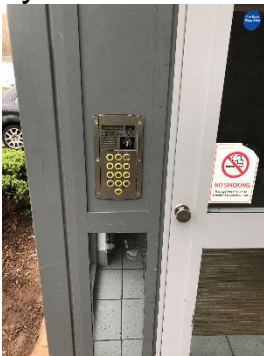
- 1) Regular checks are undertaken by Caretakers / Cleaning Team(s) 365 days per year which helps reduce the risk of arson.
- 2) Restricted access to the premises by means of a door entry system.
