# Fire Risk Assessment

**15-19**

**New Hope Road,  
Smethwick,  
B66 3TY**

**Date Completed: 06/07/2026**

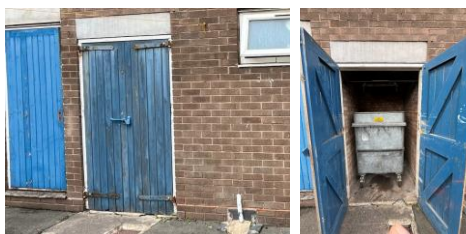
The blocks bin store is located at rear of the premises and built within the block. This is secured by two timber doors. Within this store is a commercial-grade metal wheelie bin, functioning as the receptacle for refuse discharged via the block's bin chute.

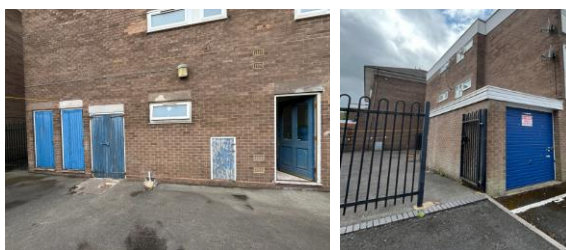
Adjacent to the bin storeroom, within the same wall, there are three individual storage rooms allocated to specific flats, accessible only by the respective residents. Also located within this wall is the entrance door to the ground-floor flat. This rear area forms part of a secure courtyard, enclosed with metal railings and gated access.

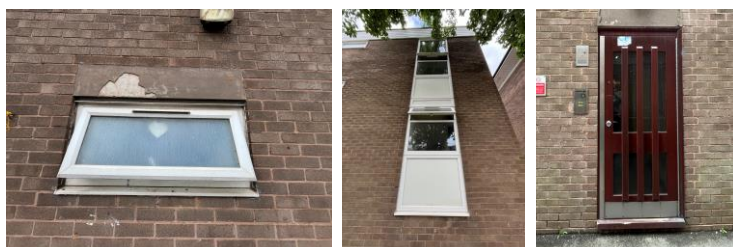
- 2) uPVC double-glazed units have been installed in each flat and within the communal stairway, most of the large units have spandrel panels fitted on the lower sections of the units. The entrance doors are a timber construction with glazed panels.

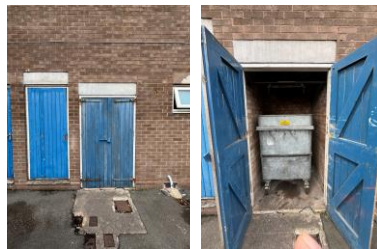
- 4) The blocks bin store is located at rear of the premises and built within the block. This is secured by two timber doors. Within this store is a commercial-grade metal wheelie bin, functioning as the receptacle for refuse discharged via the block's bin chute.

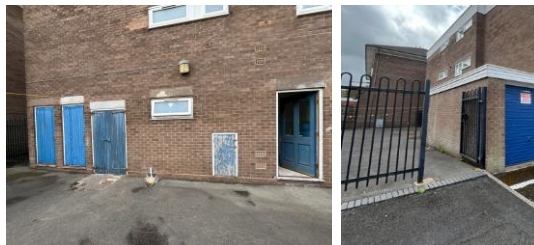
- 5) Adjacent to the bin storeroom, within the same wall, there are three individual storage rooms allocated to specific flats, accessible only by the respective residents. Also located within this wall is the entrance door to the ground-floor flat. This rear area forms part of a secure courtyard, enclosed with metal railings and gated access.

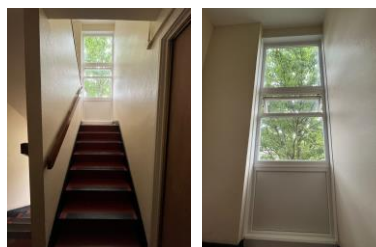
- 9) Automatic smoke ventilation is not employed. Windows fitted on the stairwell are fitted with manual openers; the windows will assist in additional lighting and any ventilation required.

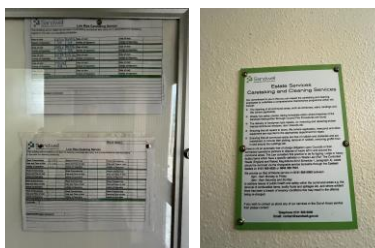
- 11) Communal areas are kept free of flammable items. The communal areas are checked on a regular basis by Caretaking / Cleaning teams 365 days per year and all items of rubbish are immediately removed. There is also an out of hour's service that allows combustible items of furniture / rubbish to be removed.

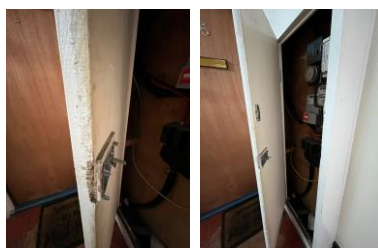
- a) The service-cupboard door has a faulty locking mechanism and cannot be secured. The lock requires replacement to ensure the cupboard can be properly secured, thereby maintaining the safety of the escape route.**

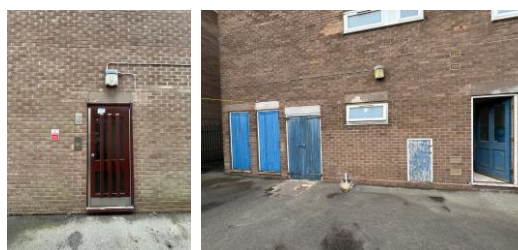
- 3) Safety/security lighting is installed above the external entrance doorway. And within the courtyard

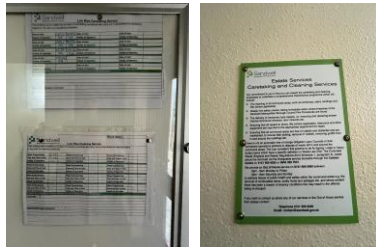
- 1) There is a regular Cleaning Service to the premises.

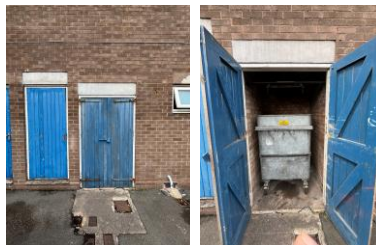
- 2) The refuse bins for 15-19 New Hope Road are stored at the rear of the premises within a designated internal bin-storage cupboard, which is built into the structure of the building. This area also serves as the bin-chute room, with hopper doors located on the first and second floors for residents to dispose of waste. The bins are emptied as part of the routine waste-collection service. This storage area is secured by two timber doors.
