Fire Risk Assessment

Park Close, 1-3, Tividale, Oldbury, B69 1NJ.

Date Completed: 02/04/2026

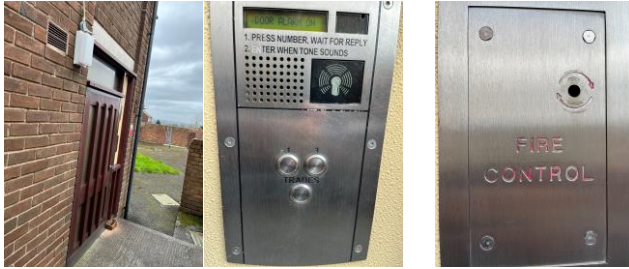
The block has an entrance to the side elevation, that has a door entry system with a fob reader installed. The escape routes lead to an ultimate place of safety. The front final exit door has a firefighter override switch operated by drop-latch key. The door entry system is designed to fail safe and unlock in the event of a power failure.

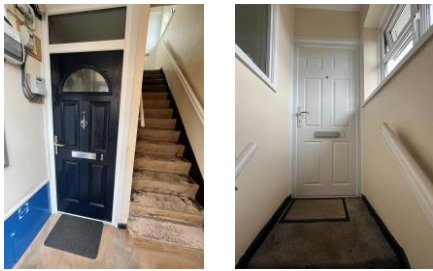
- 1) Flat 1 has a FD30s rated composite fire doors which is glazed with a transom and Flat 3 has a FD30s rated composite fire doors which is not glazed.

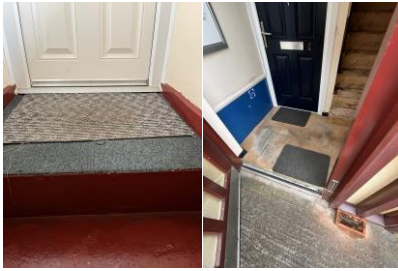
- 5) It is noted that both flat entrance doors have door mats. The fire rating of these is unknown but are deemed low risk.

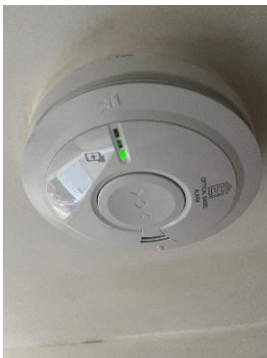
Flat 1 was accessed and was seen to be LD2 standard.

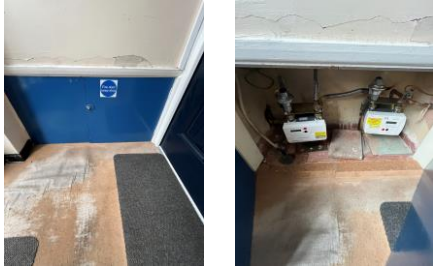
- 7) The gas meter is in a service cupboard in the communal entrance Just below the electrical installation. This is not to current regulations it has no ventilation to outside and no lockable fire rated doors. An email has been sent to the gas team to contact cadent about relocating the gas meters to outside. See observations.

- a) As no future works are planned with Cadent to relocate the gas meters, recommend permanent ventilation being provided. This should include the installation of a ventilation brick or equivalent arrangement to ensure compliant airflow to the exterior of the property. This has been added to recommendations to be undertaken at a future refurb date. Meeting held on the 13/02/2026 concluded that the service cupboards would be surveyed for the addition of ventilation being added to the outside of the building.
