# Fire Risk Assessment Bearwood road 139 Flats 1-5

### Bearwood Road, Smethwick, B66 4LN

**Date Completed:** 19/04/2024.

**Current Risk Rating = Tolerable**

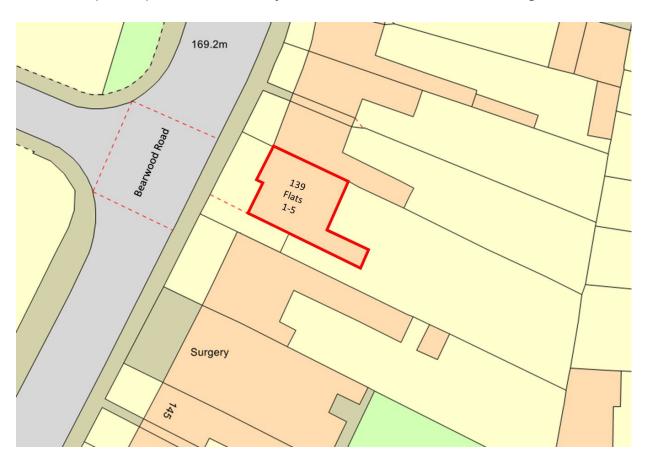
### **Building Plan**

The floor plans provide basic layout and location of the building.

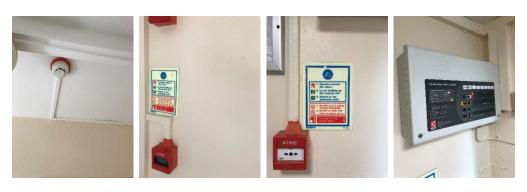
- 14) Due to undertaking a type 1 fire risk assessment, when a property becomes void or as part of future works, measures shall be taken to undertake a destructive survey to the converted flats to confirm a minimum of REI 30-minutes fire protection between flats and communal areas at floor and wall levels.
- 15)Communal fire alarm has been introduced along the means of escape within the corridors and staircase with call points and alarm sounders strategically located on each floor. The fire alarm control panel can be located on the ground floor nearest the final exit door. Evidence provided of weekly tests.

16) Individual flat doors are Nominal composite/ timber construction.

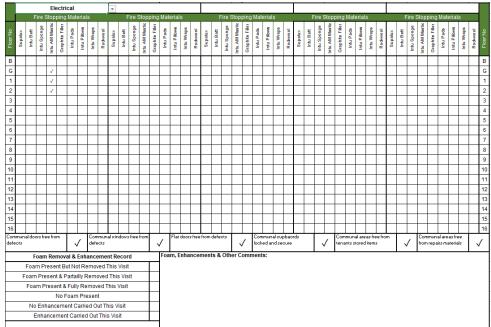
- 2) The building should be designed to provide as a minimum 30-minute vertical fire resistance and 30-minute horizontal fire resistance around flats stairwells and. All doors are 30-minute fire resistant with cold smoke seals this will need to be determined under future works.
- 3) there is a cyclical programme to ensure fire stopping has not been compromised by third parties and where applicable enhance the fire stopping within communal areas.
- 4) There are no communal fire doors fitted within the building.
- 5) Cupboards within the communal areas were not secured during the FRA.
- 6) A variety of methods / materials have been used to achieve firestopping including Rockwool, fire rated sponge and intumescent pillows.
