Fire Risk Assessment

Sampson Close 1-6

Sampson Close Tividale, B69 1NL

Date Completed: 1st April 2026

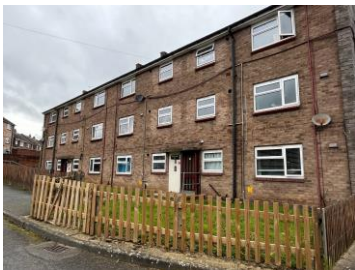
Ground floor – flats 1,2
1ST floor – flats 3,4
2nd floor – flats 5,6

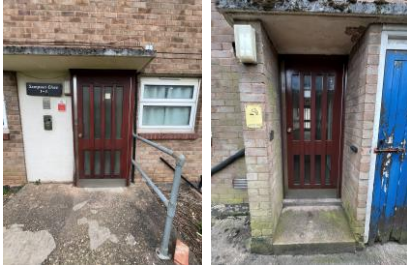
Front and rear entrances to block

Main entrance to the building is through a timber door, with both the front and rear doors accessed via fob reader, trades and visitors use an intercom system. For emergency access there is a firefighter manual override switch located above the door intercom panel.

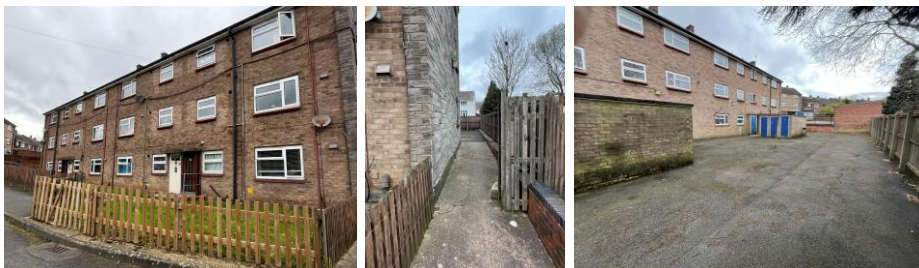
Externally the building has a timber fenced perimeter and access to the rear from the left side of the building, this leads the rear courtyard

timber fencing perimeter and courtyard at the rear.

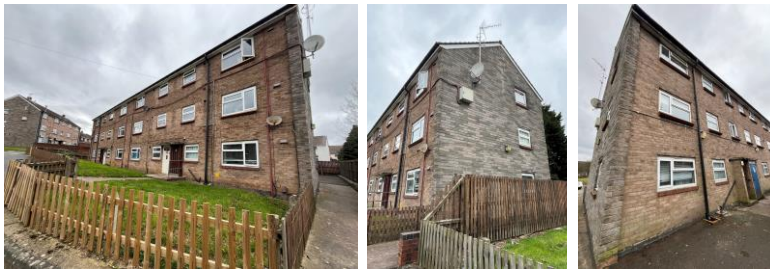
- 1) The exterior of the building is predominately traditional brick construction with a pitched roof design with UPVC fascia boards to the roof line and interlocked concrete roof tiles above. Front entrance is through timber doors.

Front Elevation

Side and Rear Elevation

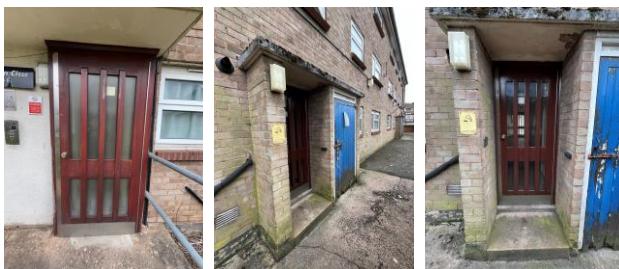
- 2) Both the front and rear doors are of timber construction and incorporate glazed inserts. The front entrance is positioned beneath a concrete canopy, while the rear door is recessed within a brick and concrete alcove. Adjacent to the rear exit is the refuse bin store, which is enclosed by a timber door.

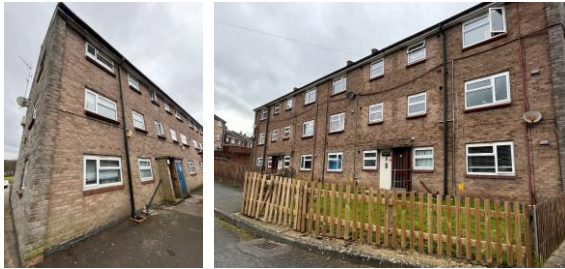
- 3) UPVC double glazed window units have been installed for each flat and communal areas within the block.

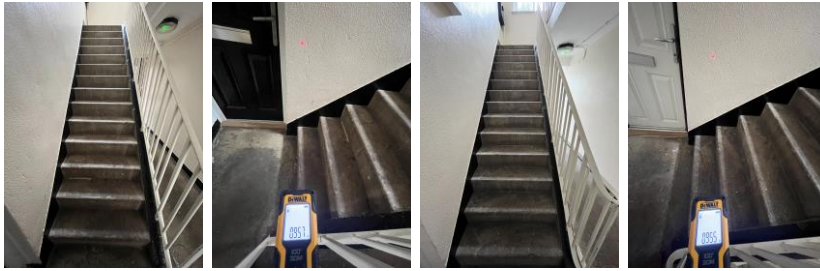
Ground to 1st & 2nd floor staircase.

- 4) 1-6 Sampson Close consists of a single staircase that provides sufficient means of escape, this is located as you enter each block. The width of the staircases has been measured from handrail to handrail at a measurement of 957mm and 955mm These stairs are kept clear to maintain safe means of escape.
-

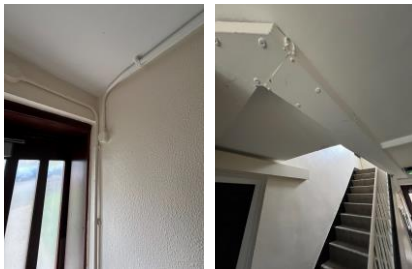
- 9) All electrical cabling installed within the communal corridors and escape routes are channelled via metal electrical trunking and metal conduits.

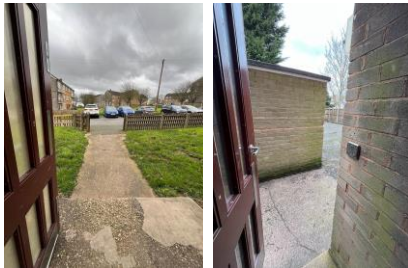
Front and rear final exit routes

- 11) The route out the block to ultimate safety is clear from both final exit doors.

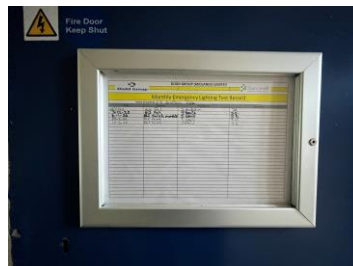
8.552		
System Details		
Manufacturer	Number of Fittings Onsite	
kosnic	6	
Inspections and Tests		
Type of inspection	Any luminaires having a repair has been internally cleaned	Are all luminaires labelled
MONTHLY	YES	YES
All luminaires and/or signs are functioning correctly	NO	Log book completed
FAIL	A visual check of the fixed wiring installation has been carried out	YES
Each luminaire has been checked to ensure that the normal supply has been restored	YES	Comments
YES	Has any alteration to the building structure or layout affected the effectiveness of the emergency lighting system	
All luminaires have been externally visually examined	NO	
YES		
Sign Off Area		
NAME OF ENGINEER	New Signature	New Date
jarrile davis	<i>J. Davis</i>	10/03/2026
Photos		
Photo Attachments	Photo Attachments	Photo Attachments
Photo Attachments	Photo Attachments	Photo Attachments
Repairs

- 4) Emergency lighting is installed throughout the building; units are installed in communal areas e.g. stairways & corridors.

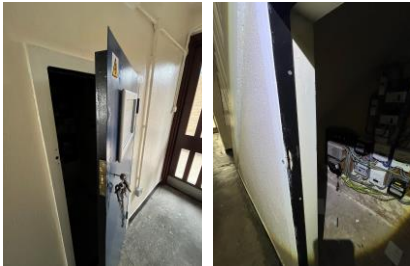
Electrical cupboard in the communal hallway that is a evacuation route requires smoke and intumescent strips to provide suitable compartmentation.

- 3) **Electrical Service cupboard on the ground floor which accommodates the residents' electrical meters and other electrical apparatus is secured by a steel door and accessed using a 138 key, this door does not have smoke or intumescent seals installed. Noted in Observations for a certified FD30s fire door to be installed on any future works programme**

At present the temporary installation of smoke brush seals to the steel on the electrical cupboard which is in the communal escape route out of the building are acceptable, but for best practice it's advised that certified fire door with smoke and intumescent seals is to be installed on any future works programme of the block.

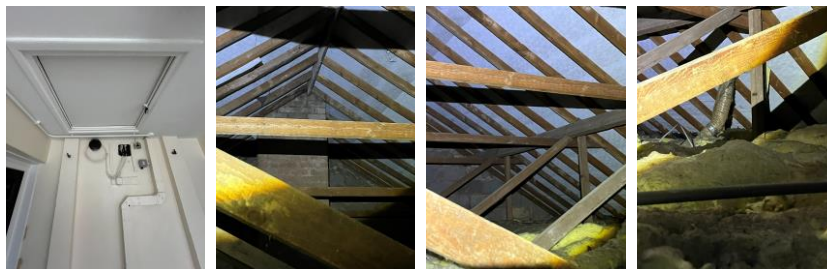
- 4) Access to the roof is by means of roof hatch which is on the 2nd floor landing. Compartmentation inspected within the roof space; there is no evidence of any breach in the compartmentation. Noted that there is an extraction fume venting out the roof. Rockwool insulation is layered within the Joice.

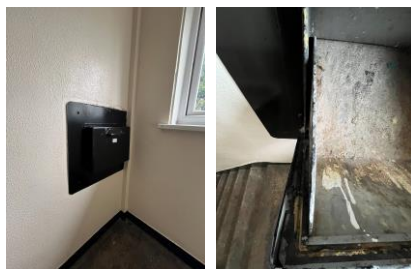
6) Intumescent seals have been installed with the chute hoppers on the 1st and 2nd landing

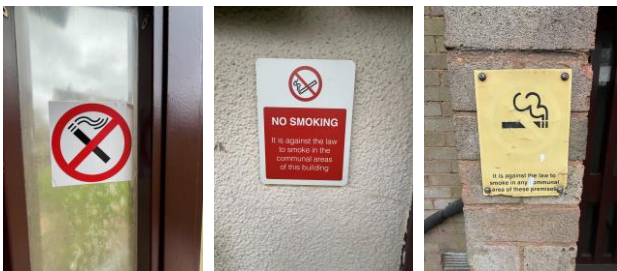
- 2) Yellow LPG warning signs are not displayed within the block. [refer to section 18](#).
- 3) Smoking is prohibited within any communal parts of the building in line with Smoke Free England legislation. Signage is also displayed in the external refuse cupboard located next to the entrance doors.

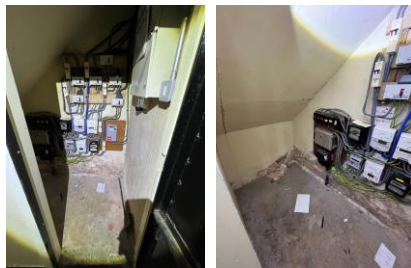
- 1) Smoking is prohibited on entrance and within any communal parts of the building in line with Smoke Free England legislation.
- 2) Hot working is not normally carried out. If essential maintenance requires the use of hot work processes, then corporate policies and procedures are to be followed.
- 3) Portable electrical equipment used as part of the Caretaking / Cleaning regime is subject to annual PAT Testing. This information is held by the Estate Services Manager.
- 4) The fixed electrical installation shall be tested every 5 years. Waiting on **Satisfactory EICR** from electrical team. *Email sent on the 23/03/2026 2026 remedial work has been scheduled in for the block,*
- 7) Electrical service cupboard on the ground floor which is located within the communal corridor near the rear final exit, this is secured behind a steel door. Cupboard is free from any combustibles.

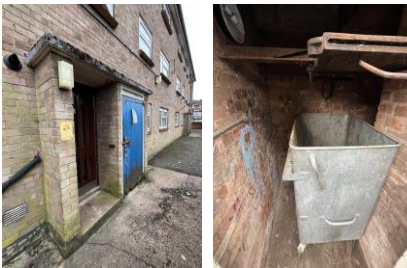
- 2) Refuse bin is stored in a secured bin room that is located next to the rear entrance of the building. This is kept secure by a means of a sliding bolt. Bins Are regularly emptied by site services.

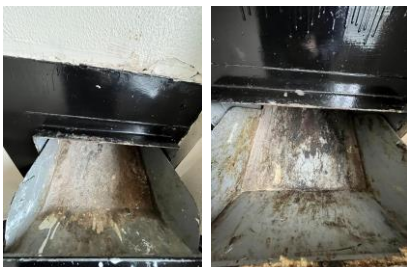
- 3) Both 1st and 2nd floor internal refuse chutes are clear of any rubbish.

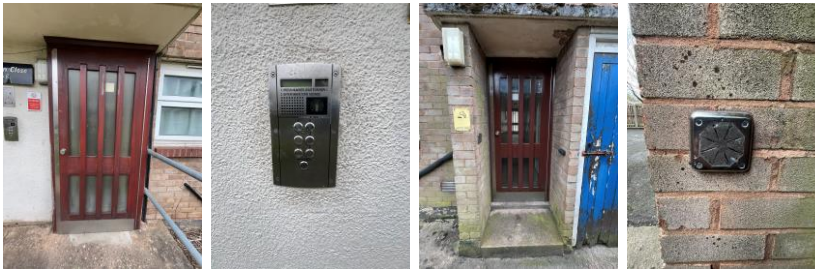
Front and rear entrance doors with access system.

- 1) Regular checks are undertaken by Caretakers / Cleaning Team(s) 365 days per year which helps reduce the risk of arson.
- 2) Both blocks have restricted access, this is via a key lock, each resident has their own fob to gain access. There is an intercom system that can allow visitors and contractors in.

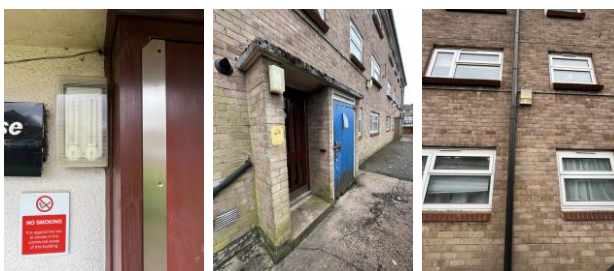
- 3) There is no current evidence of arson.
- 4) The perimeter of the premises is well illuminated. The front and rear both have external lighting units installed.

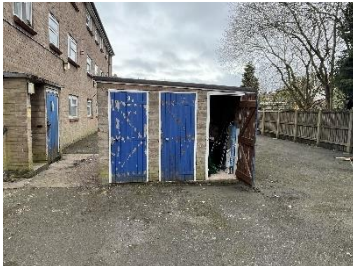
- 1) Residents instructed not to bring L.P.G cylinders into block.
- 2) The tenancy conditions, Section 7 – Condition 5.6 stipulates “If you live in a flat or maisonette, you, people living with you and any visitors to your property must not keep or use paraffin oil, petrol, bottled gas appliances or any other explosive, FLAMMABLE or dangerous material in the property. This restriction also applies to any storage facility situated in or attached to the block, which has been provided for your use.”
- 3) No Flammable liquids stored on site by Caretakers / cleaners.
- 4) There are no flammable liquids or gas cylinders stored on site.
- 5) Residents have external storage units to the rear of the building; these are kept secure by residents themselves.
