# Fire Risk Assessment

## Greenford House

**Maria Street, West Bromwich,  
B70 6DX**

**Date Completed:** 20/12/2024.

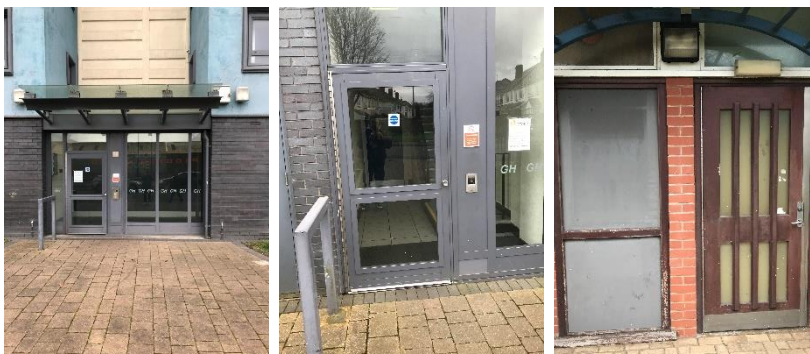
There is a main entrance/ exit to the front elevation with an additional entrance/exit to the rear elevation that residents have access to, there is an additional entrance to the side elevation that was accessed by office staff.

Front entrance acts as the main access for both residents and office staff.

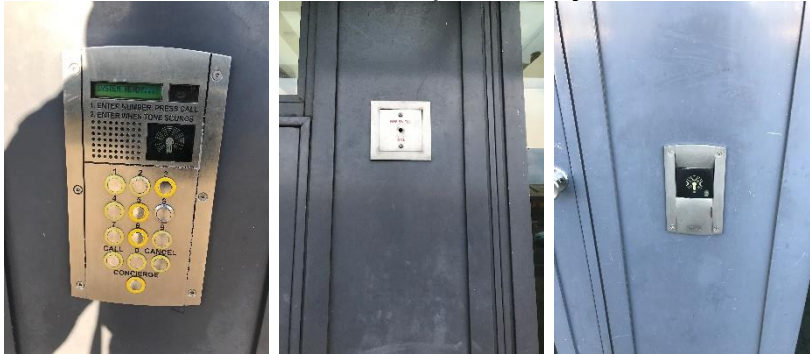
Front, side, and rear entrances utilise fob access in order to gain entry to the block with the front entrance also utilising a firefighters override switch in the form of a drop latch system.

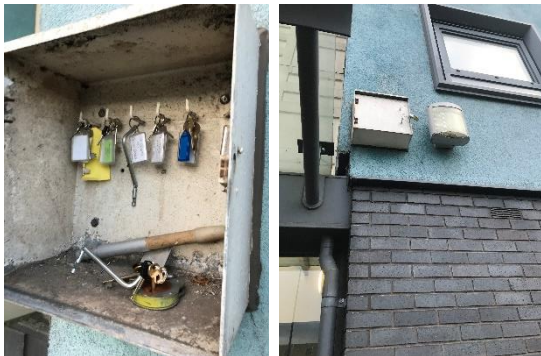
The fire fighters' white box is located to the right-hand side of the front main entrance. An updated version of the orientation plan showing service isolation points for gas, electricity and water are detailed on a within the PIB.

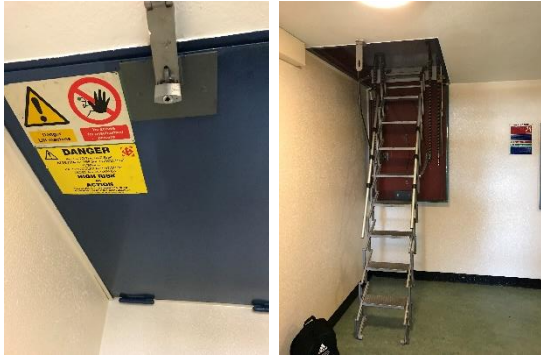
The block has a two lifts accessed on the ground floor that serve alternating floors of the block. Lift motor room accessed via a loft hatch with zip ladder on the 16<sup>th</sup> floor with keys stored within the fire fighters white box.

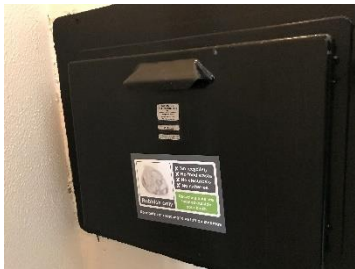
Residents have access to a bin chute system that serves every floor of the block secured behind notional 44mm FD30s doors with combined intumescent and smoke seals.

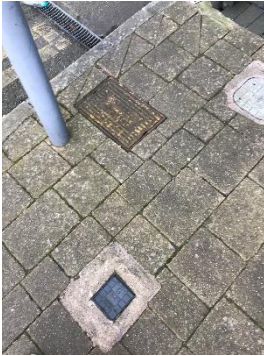
The fire hydrant can be located at the rear elevation of the block and can be found on the orientation plan located in the premise information box.

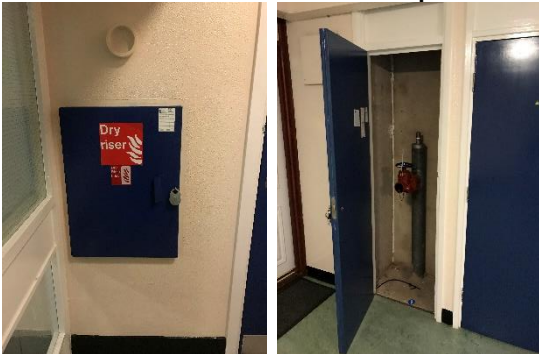
There is a dry riser that serves all floors of the block with a dry riser inlet cupboard located on the ground floor which is a steel door that is adequately signed and secured with a padlock, each floor of the block contains a dry riser protected via notional 44mm FD30s doors with combined intumescent strip and smoke seals.

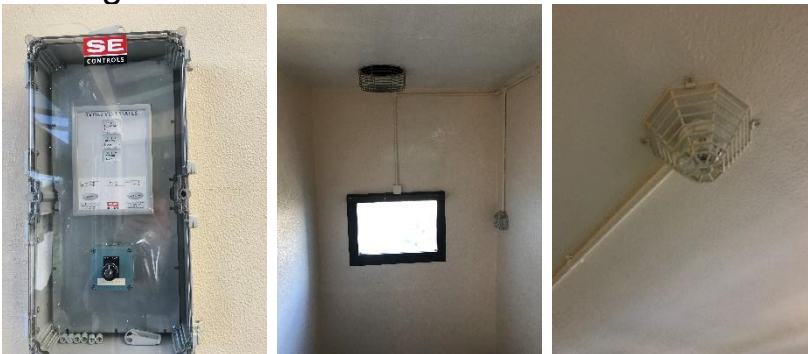
AOV's are in operation on the 2<sup>nd</sup>, 8<sup>th</sup> and the 16<sup>th</sup> floors within the protected stair with natural ventilation to each floor of the block within the landing area of each floor.

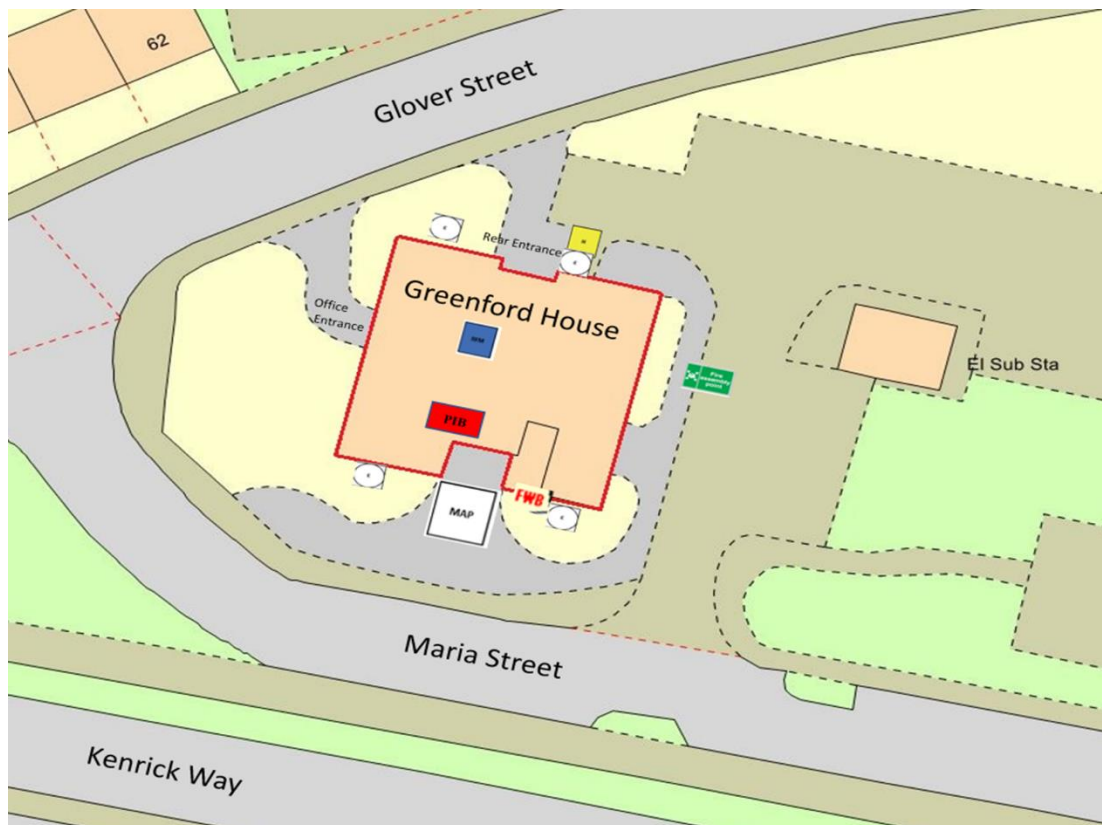
A typical floor layout showing horizontal lines of compartmentation, lift shafts, dry riser installation etc on the ground and an intermediate floor.

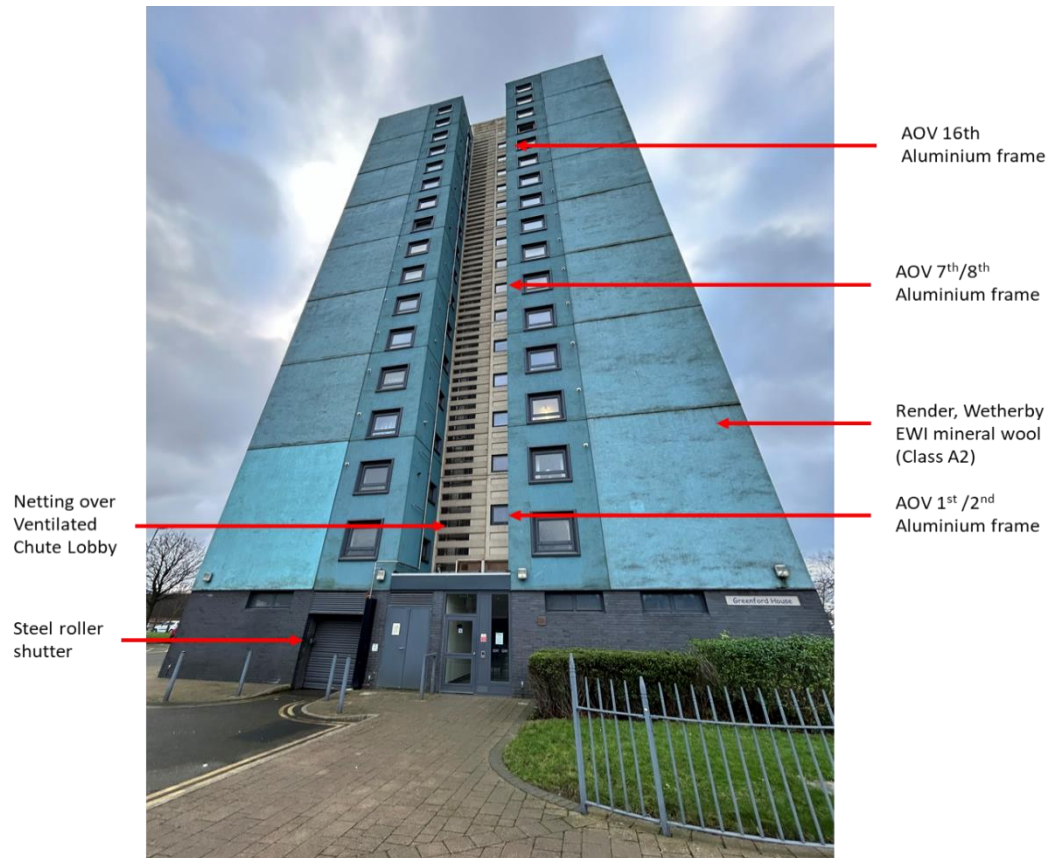
- 1) The block was constructed of a Insitu concrete frame with masonry infill (Wates) construction, last refurbished in 2010 with the addition of a external wall system. The external facade consists of high density laminate board (B,s1, d0), Rockwool insulated render (A2), brick (A1) . The combination of the materials used present an **acceptable** level of risk.

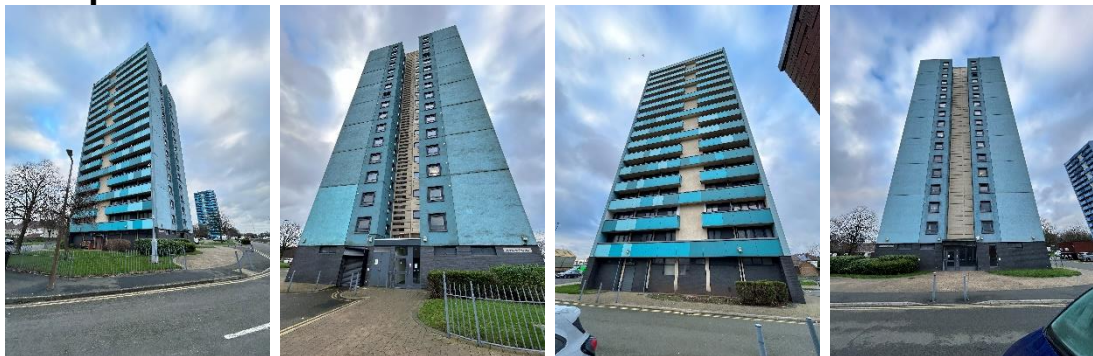
- 2) External facade is made up of four materials 1% brick, 53% render, 28% Glass, and 18% balcony cladding (high density laminate).

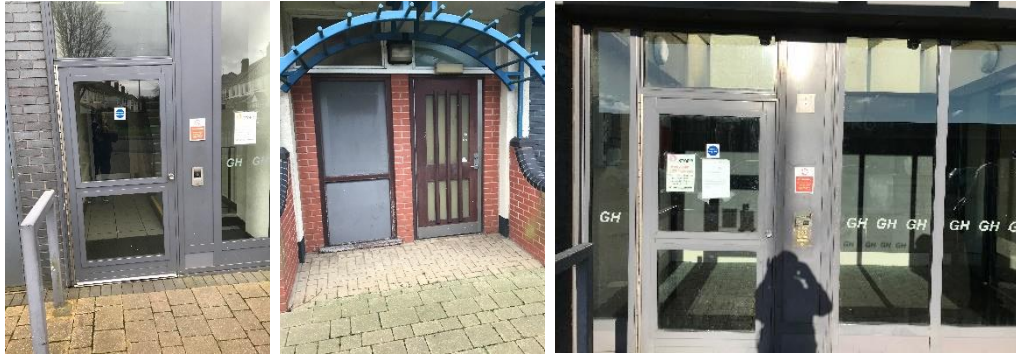
- 3) Front and rear entrance/exit is constructed of an aluminium door and frame with double glazing. Front entrance you pass through two sets of doors before entering the ground floor lobby area. Additional side entrance is a timber door and frame.

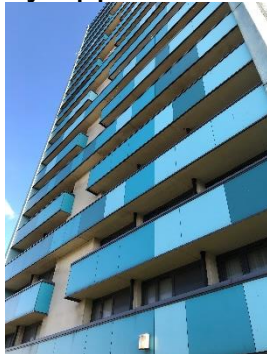
- 4) Residents have access to balconies, Trespa over cladding to a concrete panel between balconies with 100mm rockwool insulation by approved aluminium cladding.

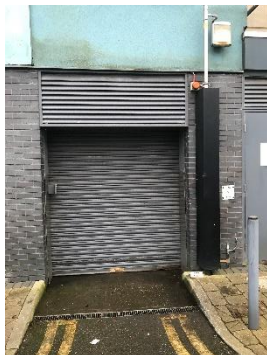
- 5) Bin store located at the rear elevation of the block; bin store is secured with a steel roller shutter door.

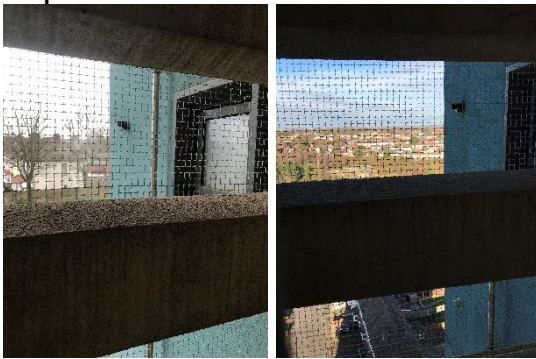
- 8) Open air natural ventilation Along the bin chute lobby area made of concrete construction along the rear elevation, it was noted that netting was present along this section of the premise. The netting does not run down to the ground level and does not have easy access combined with sufficient compartmentation and the stay put unless policy reasonable measures have been made to reduce the risk. However an alternate option should be explored when future improvement works are conducted.

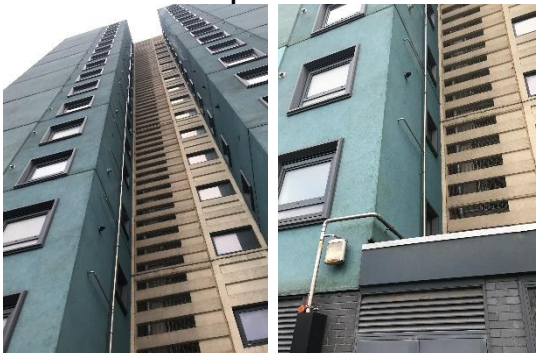
- 9) Gas was noted to be external running along the rear elevation. Gas isolation points located on the orientation plan.

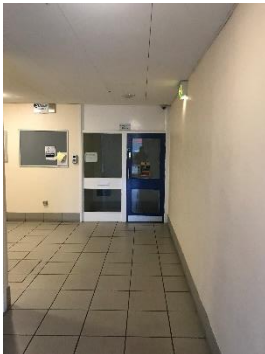
- 1) The sites residential parts have a single staircase serving all floors of the block providing a means of escape located at the rear of the building with stairwell being a sufficient width from 980mm.
- 2) All corridors are of adequate width (at least 1050mm) and will be maintained clear to that width as a minimum.

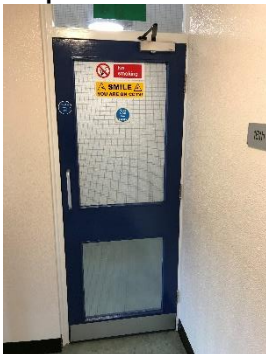
- 3) There are no corridors that form a part of the means of escape that are a dead end.
- 4) The means of escape are protected to prevent the spread of fire and smoke by means of nominal/notional fire doors and good compartmentation between lobby areas, staircases, storage rooms, and dwellings.
- 5) The communal landing / staircases are protected by use of self-closing 44mm notional 30-minute timber fire doors with vision panels. All doors have been upgraded with combined intumescent strips / cold smoke seals.

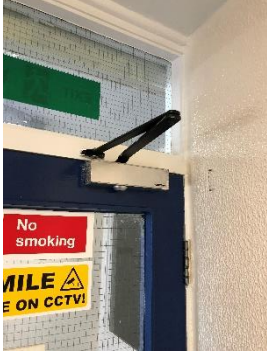
- 6) All communal doors are fitted with automatic closing devices that are checked on a regular basis by Caretaking Teams as part of their checks. Defective closing devices are replaced either by the Caretaking Team(s) or the in-house repairs team(s).

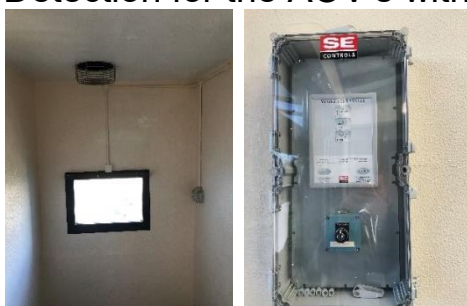
- 9) Automatic smoke ventilation is employed. This is tested, inspected, and maintained by a competent procured contractor in accordance with BS7346. The frequency for the maintenance checks are twice per year (April and October) of each calendar year. AOV's are located on the 2<sup>nd</sup>, 8<sup>th</sup>, and 16<sup>th</sup> floor within the protected staircase. Detection for the AOV's within the communal areas.

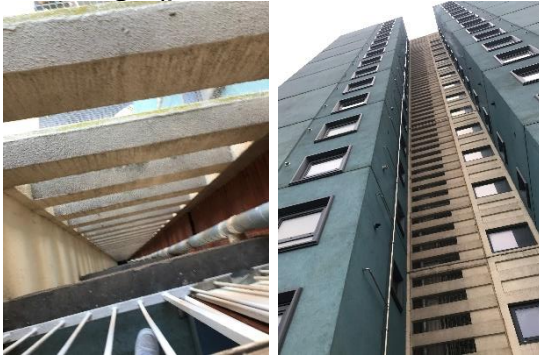
- 10) There is natural ventilation to the block along one elevation of the building. (please see section 10/18).

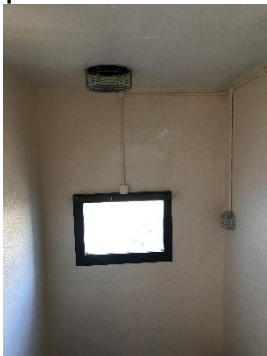
- 12) The head of the staircase contains a vent to assist with the prevention of smoke logging.

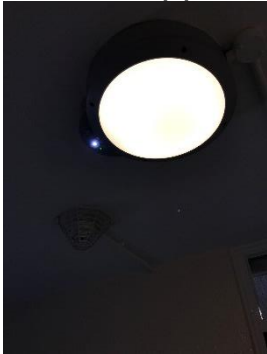
- 14) Emergency lighting is provided to communal landings and stairs. Checks are done monthly by Sandwell MBC in house electrical team or approved contractor.

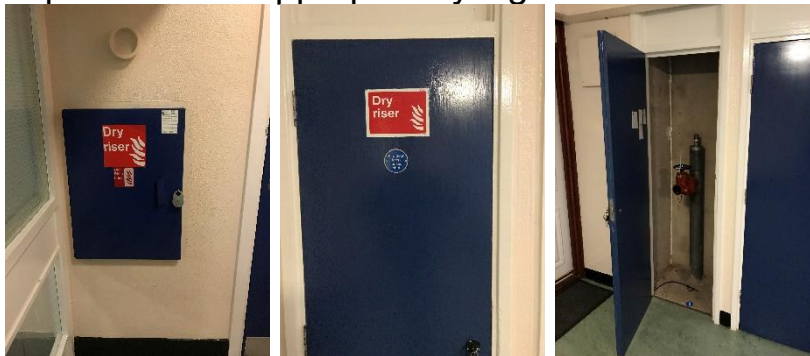
- 15) Dry riser cupboards are notional 44mm, 30-minute fire doors with combined intumescent strips & cold smoke seals throughout the block other than on the ground floor where the dry riser inlet is secured with a padlock behind a metal door. All dry riser cupboards are appropriately signed.

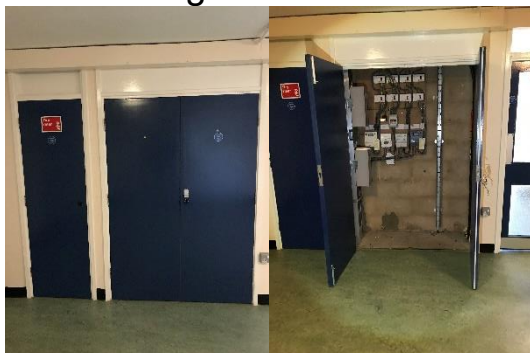
- 16) Service/electrical cupboards within lobby areas are notional 44mm 30-minute double fire doors, secured with type 54 suited mortice locks through the block.

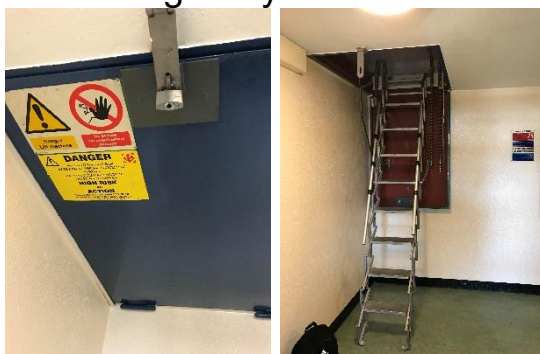
- 18) The lift motor room is located on the roof. Access to motor room via ceiling trap with zip ladder located on the 16<sup>th</sup> floor. A full height door then gives you access to the roof.

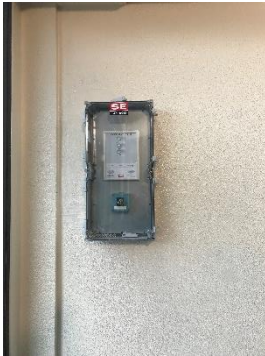
- 23) Smoke control systems located on the ground floor near the main entrance to the block.

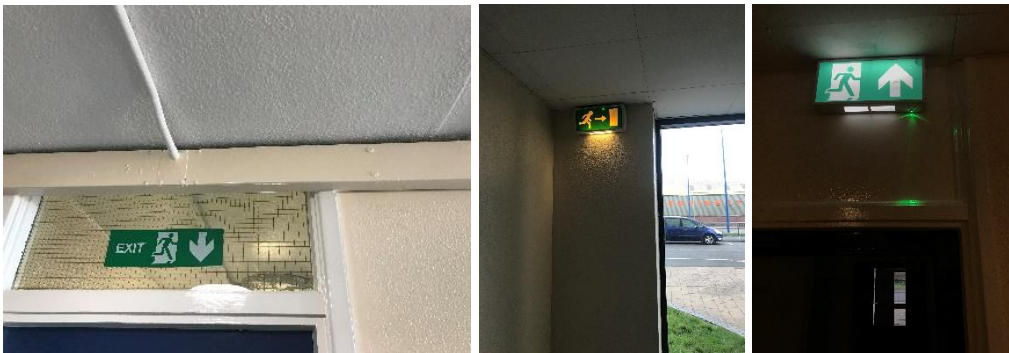
- 24) Directional signage has been implemented on all floors of the block.

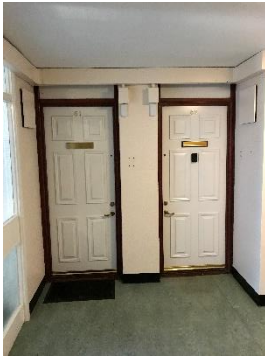
- 8) Any remedial works arising from the fire stopping / compartmentation check(s) will be actioned immediately by the Fire Safety Rapid Response Team.
- 9) Individual flat doors are predominantly nominal 44mm fire door sets with intumescent strips, cold smoke seals and self-closing devices.

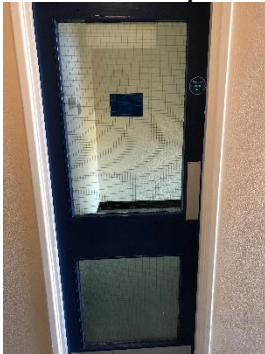
- 10) The communal landing, staircases & chute rooms are protected by use of notional self-closing 44mm 30-minute timber fire doors with vision panels & 25mm stops.

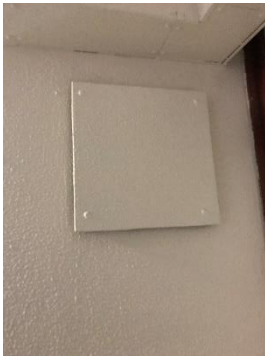
- 12) Access panels to stop taps are fixed to masonry and bedded on Intumescent material.

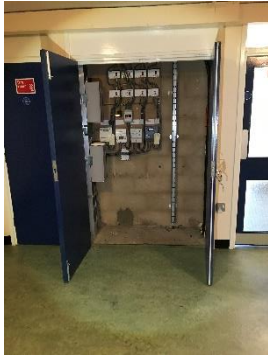
- 16) The use of expanding foam was present within the communal cupboards around cabling as part of the fire stopping knowing that intumescent pads and a concrete slab is present and this foam is only used as an enhancement it is deemed tolerable. This should be enhanced as part of future works to the building and replaced with intumescent mastic to improve fire stopping.

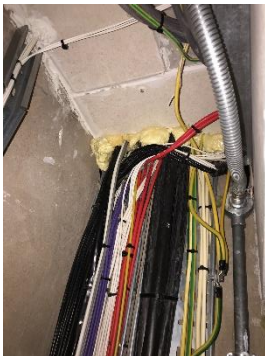
- 17) Some wear and tear was beginning to show on some cold smoke seals on communal doors and communal cupboards however will still serve their purpose in the event of a fire.
- 18) Some cupboards located on the ground floor including caretaking/cleaning cupboards are notional 54mm FD60 timber doors.
- 19) Cupboard where the electrical risers and the bin deluge system panel is stored is a notional metal door.
-

It is noted that there is some wear and tare was beginning to show on some cold smoke seals on communal doors and communal cupbards however this will not effect the performnace of the door.

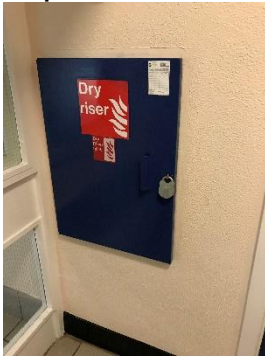
- 1) The dry riser inlet cupboard is located in the ground floor lift lobby and is appropriately signed. The riser is accessed behind a metal cupboard and secured via a padlock.

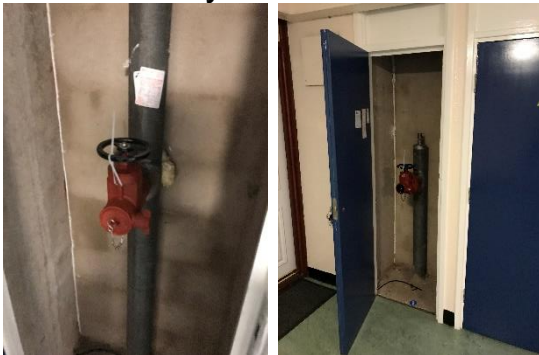
- 2) The riser outlets are available on each floor lobby (1<sup>st</sup> – 16<sup>h</sup>) these are protected via notional 44mm 30-minute fire doors secured by suited 54 key & mortice locks.

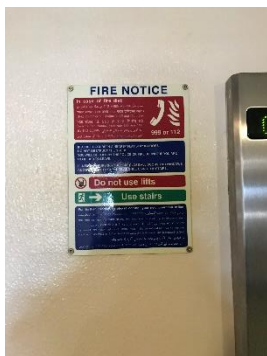
- 2) Fire Action Notices are displayed throughout the building.

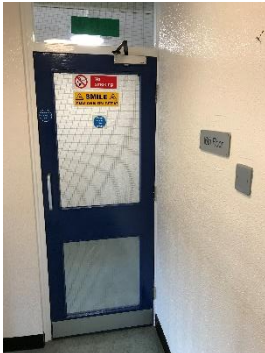
- 5) Wayfinding Signage to the block depicting floor level and flat numbers has been installed to the wall adjacent to lift and within the staircase. This meets the requirements set out in the Fire Safety (England) Regulations 2022.
- 6) Currently there is signage on each floor of the block as well as on the wall of each floor from the staircase including the new photoluminescent signage installed with the introduction Fire Safety (England) Regulations 2022.
- 7)

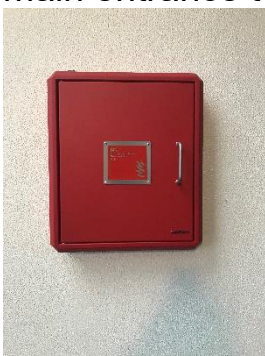
- 8) Premise information box is signed appropriately and located at the main entrance to the block.

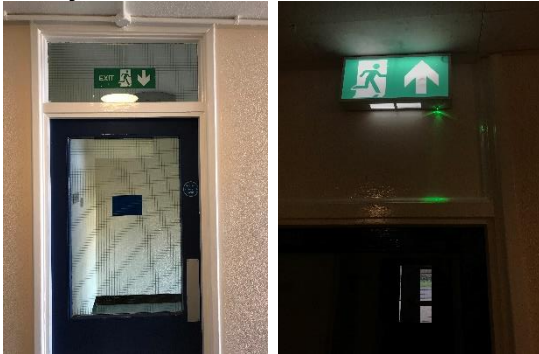
- 9) The fire escape routes have directional signage placed within the block, note the illuminated emergency escape light testing records are yet to be established and should be confirmed.

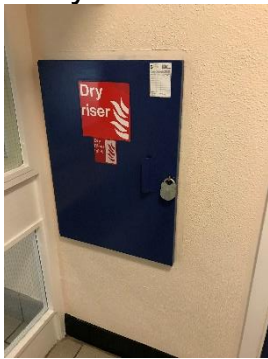
- 10) Dry risers are appropriately signed.

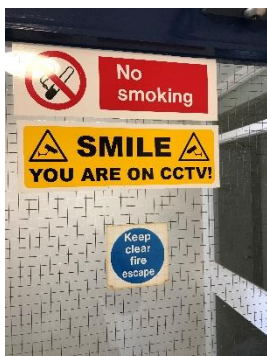
- 1) Smoking is prohibited within any communal parts of the building in line with Smoke Free England legislation.

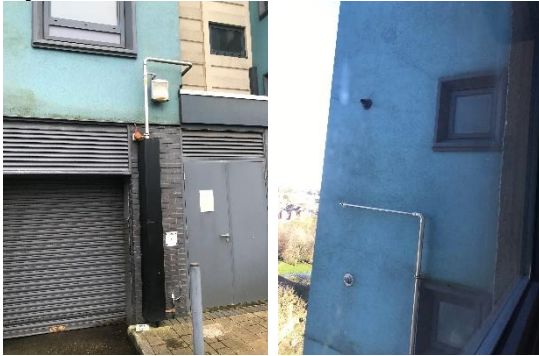
- 6) There is lightening protection installed to the block. Maintenance contracts are in place for lightning conductor testing in accordance with BS 6651.
- 7) Portable heaters are not allowed in any common parts of the premises.
- 8) Gas appliances and pipework (where installed) are subject to annual testing and certification. This cyclical contract is managed by the in-house Gas Team. **Gas installed is external.**

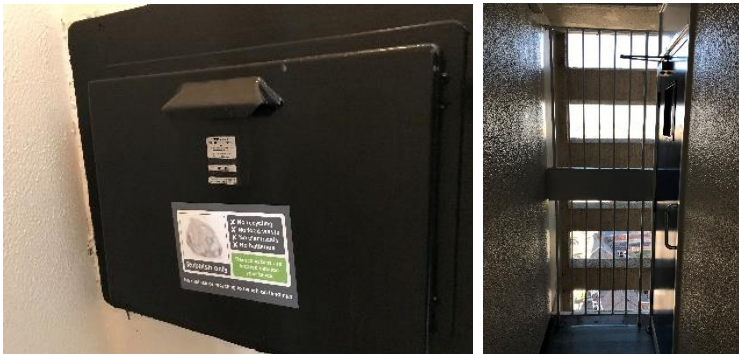
- 2) Refuse hoppers are accessed on each floor secured behind its own dedicated notional 44mm 30-minute door with combined intumescent and cold smoke seals.

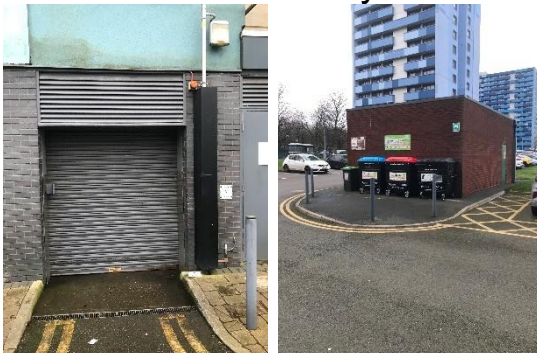
- 3) Refuse containers regularly emptied bin store located at the rear elevation of the block. There is also a recycling project currently being undertaken at the block, recycling bins are stored at a suitable distance away from the block within the car park.

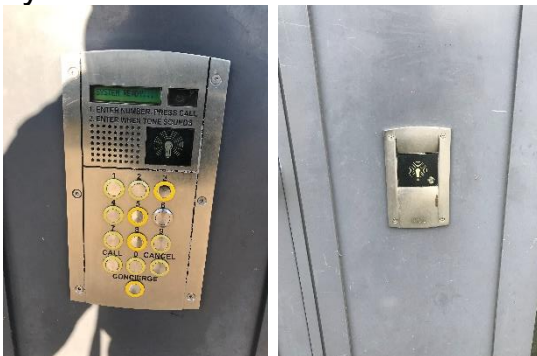
- 2) Restricted access to the premises by means of a door entry system.

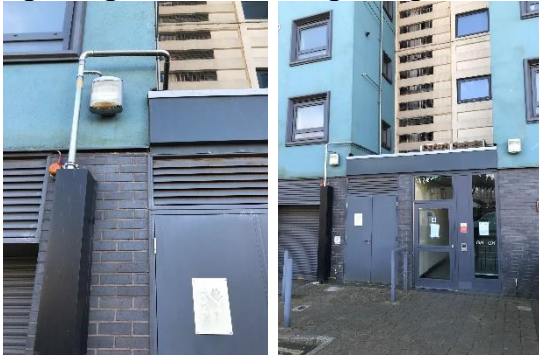
- 5) The perimeter of the premises is well illuminated with external lighting and street lighting.

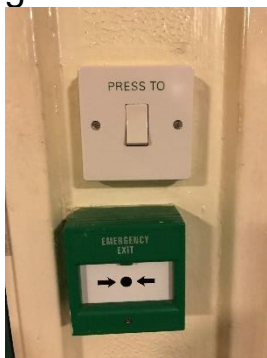
- 9) Kitchens are located the furthest point away from the exit doors (see plans).
- 10) Push to exit buttons allow safe easy exit from the office space into the protected staircase or Lobby areas, thumb turns in place on ground floor doors leading lobby area.

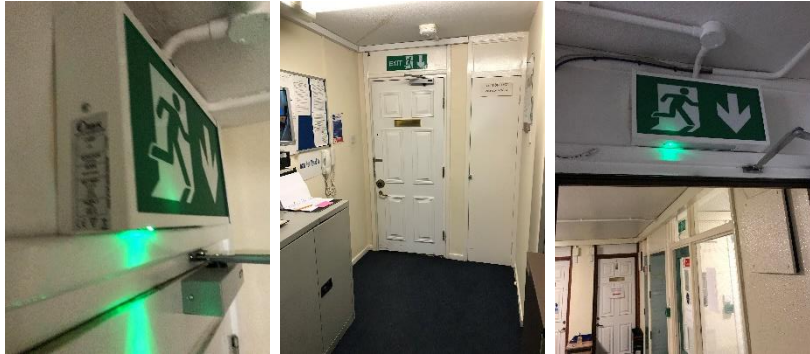
- 12) Fire action notices are strategic placed along the means of escape depicting what to do in the event of a fire. Sign displayed on ground floor door should be removed as it may cause confusion to residents or visitors at the block, the sign also depicts incorrect information. *Caretakers have removed incorrect signage, so no further actions required.*

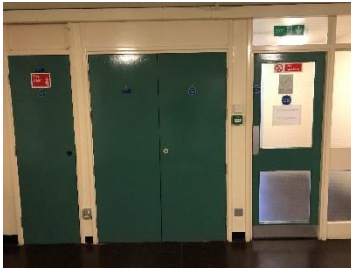
- 13) Emergency lighting is present through the means of escape.
- 14) The office spaces maintain good compartmentation from the residential units above and communal spaces with the use of compartment walls, concrete floor slab and notional fire doors throughout.
- 15) A dry riser is present within the lobby entrance in the first-floor office area with adequate signage.
-

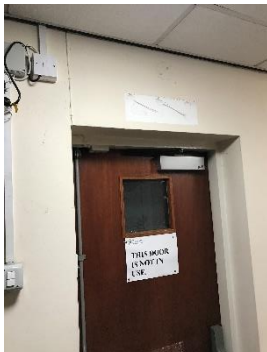
- 19) Inner rooms are used within the office, this risk is reduced due to a managed approach including robust signing in procedures combined with clear vision panels/ windows for full visibility when room is in use due to the occupancy type and familiarisation with the space this is deemed an acceptable risk.

- 20) Steel filing cabinets were observed in use within the lift lobby area. This space could be considered an extension of the adjoining offices, which in turn creates inner rooms as occupants would need to pass through the lobby to escape. It is therefore recommended that future upgrades to the premises incorporate additional early warning measures, particularly if storage in this area is maintained, albeit at a minimal level. Current mitigating factors include restricted access to staff only via fob-controlled entry and the presence of CCTV coverage.

| Because steel filing cabinets are in use within the 1 <sup>st</sup> floor lift lobby, dedicated to the office area it is recommended that smoke detection is installed as this forms part of the means of escape. | |

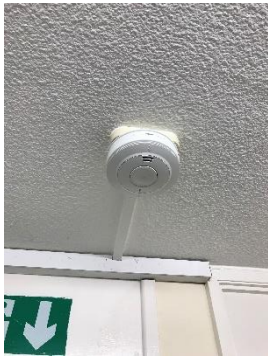
- 21) Early warning systems are limited to hard wire battery smoke alarms within the main office.

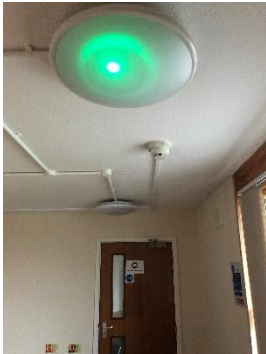
26) The premise has a sufficient emergency / escapes lighting system in accordance with BS 5266 and test points strategically located.

| 20/27 | Provide evidence of Emergency lighting tests. | | P2 | 1-3 Months Electrical | 03/02/2025 |

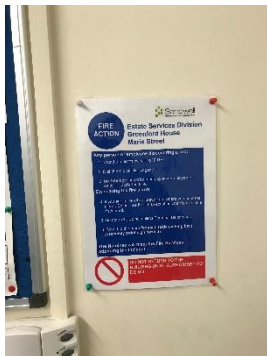
37) Fire action notices are displayed throughout the office spaces. It is not expected for employees who are not trained to use firefighting equipment. Incorrect signage was displayed during the FRA however has since been replaced.

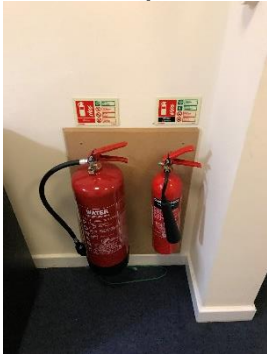
- 40) Appropriate signage has been installed for firefighting equipment's and call points.

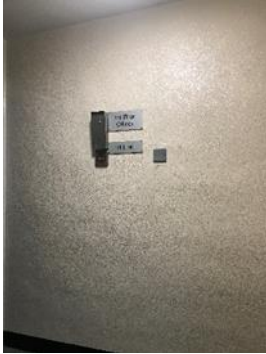
- 63) There is fob entry system that only employees that work within the office can use to access the space visitors must use an intercom and be approved access to enter.
