Fire Risk Assessment

**120-120A
Tower Road,
Tividale,
Oldbury,
B69 1NE.**

Date Completed: 02/03/2026

Current Risk Rating = Tolerable

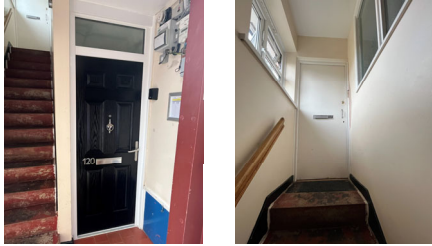
- 1) Flat 120 has a FD30s rated composite fire doors which is glazed with a transom and Flat 120A has a notional timber fire Door fitted.

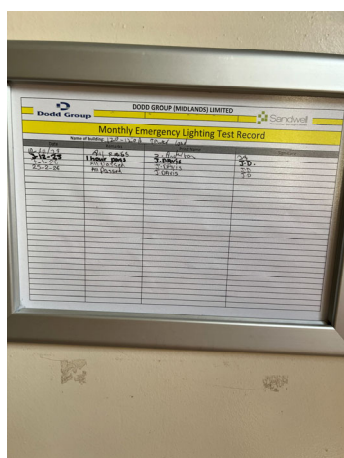
3580005-PSGA-4216-8465-886387878624

- 1) The premises has sufficient emergency lighting system in accordance with BS 5266 and has test points strategically located.
- 2) The self-contained units are provided to the communal landings, stairs.
- 3) All installed equipment is checked and tested on a monthly basis by Sandwell MBC in house electrical team or approved contractor, in accordance with current standards. The emergency lighting was subject to an in-house test on 25/02/2026.

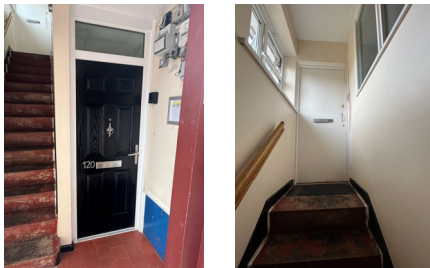
- 9) Flat 120 has a composite FD30s rated fire door fitted, flat 120A has a notional timber fire door fitted.

- 10) Although the flat entrance door of 120 is a FD30s composite door no evidence could be seen of the fire rating of the glass.
- 11) The block has a pitched roof with no loft access panel on the landing area.
