# Fire Risk Assessment

**163-163A  
Tower Road,  
Tividale,  
Oldbury,  
B69 1NE.**

**Date Completed:02/03/2026**

**Current Risk Rating = Trivial**

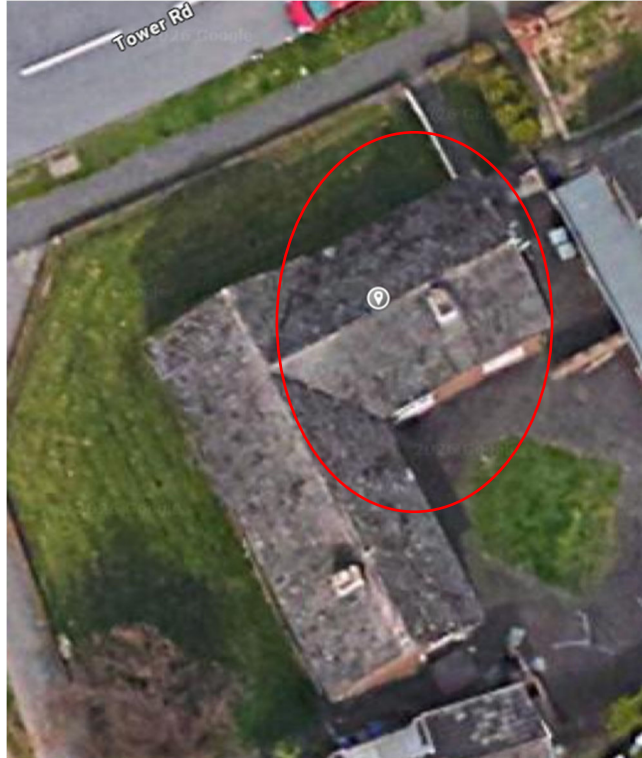
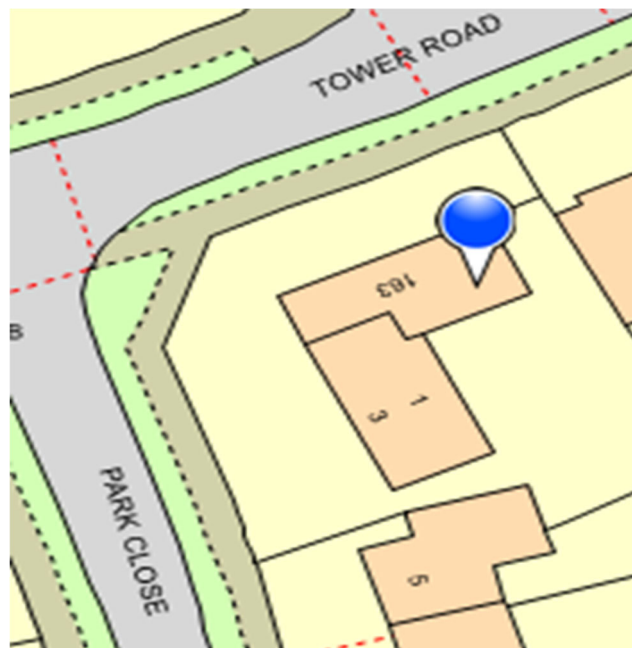
**Tower Road 163-163A.**

Plan to show the general location/orientation of the building.

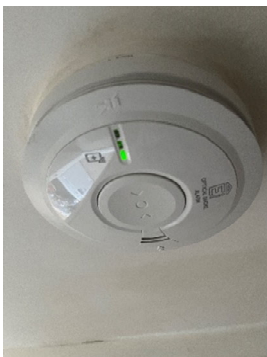
- 1) Early warning is limited to hard wire or battery smoke alarms within each of the resident's flats the equipment is subjected to a cyclical test.
- 2) Based on samples taken, the previous fire risk assessment and information kept on file (JM) the smoke alarms within resident's flats are installed to a minimum of an LD3 Standard.

Flat 163 was accessed and was seen to be LD1 standard.
