Fire Risk Assessment

**Park Close,
2-4,
Tividale,
Oldbury,
B69 1NJ.**

Date Completed: 02/04/2026

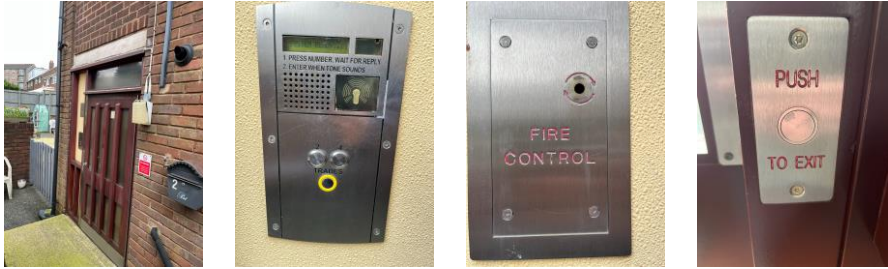
The block has an entrance to the side elevation, that has a door entry system with a fob reader installed. The escape routes lead to an ultimate place of safety. The front final exit door has a firefighter override switch operated by drop-latch key. The door entry system is designed to fail safe and unlock in the event of a power failure.

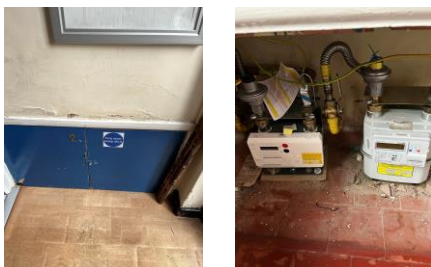
The service cupboard housing gas intakes is situated on the ground floor.

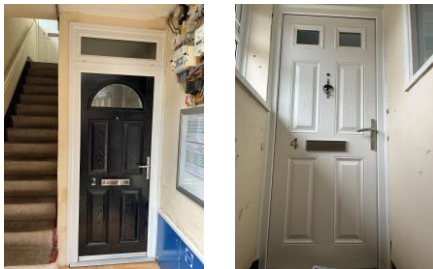
- 1) Flat 2 has a FD30s rated composite fire doors which is glazed with a transom and Flat 2 has a FD30s rated composite fire doors which is glazed

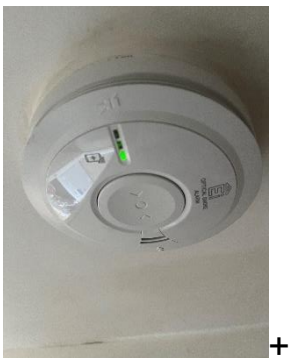
I was unable to gain access after 4 attempts at the property, so looking at the previous risk assessment Flat 2 was accessed and was seen to be LD3 standard and Flat 3 accessed previously and was seen to be of an LD3 standard.

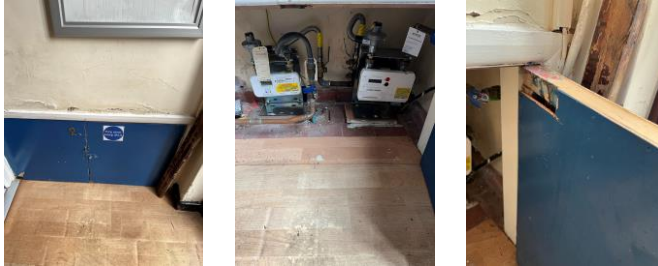
- 7) The gas meter is in a service cupboard in the communal entrance Just below the electrical installation. This is not to current regulations it has no ventilation to outside and no lockable fire rated doors. The doors have been upgraded with Supa lux board. An email has been sent to the gas team to contact cadent about relocating the gas meters to outside. See observations.

An email was sent to the Gas Compliance Manager on 19/01/2026 requesting that a job be raised with Cadent to progress this work, and the recommendation has been recorded under observations. Relevant legal and technical guidance supporting this recommendation can be found within the Gas Safety (Installation and Use) Regulations 1998

- a) As no future works are planned with Cadent to relocate the gas meters, recommend permanent ventilation being provided. This should include the installation of a ventilation brick or equivalent arrangement to ensure compliant airflow to the exterior of the property. This has been added to recommendations to be undertaken at a future refurb date. Meeting held on the 13/02/2026 concluded that the service cupboards would be surveyed for the addition of ventilation being added to the outside of the building.

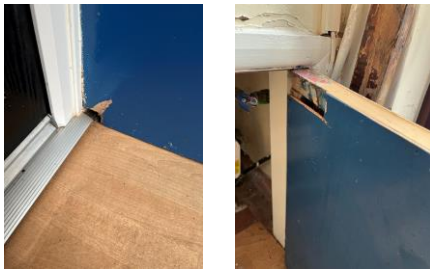
- 8) **Damage to both gas meter cupboard doors this requires a repair to both doors or both doors replacing. See Action 10/8**

Question/ Ref No	Required Action	Supporting photograph	Priority	Timescale and Person Responsible	Date Completed
10/8	Damage to both gas meter cupboard doors this requires a repair to both doors or both doors replacing.	 	P3	3-6 Months Fire Rapid Response Team

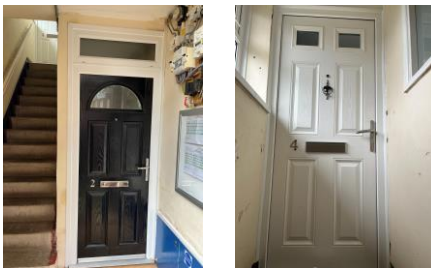
- 9) Flat 2 and 4 have a composite FD30s rated fire door fitted which protects the means of escape.

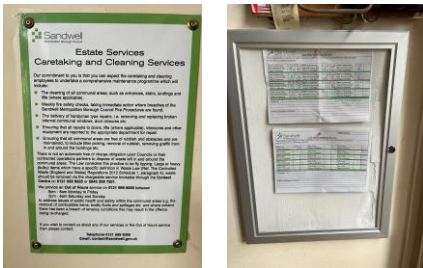
1. There is a regular Cleaning Service to the premises.
2. Refuse bins are stored to the rear of the building in the courtyard. Bins Are regularly emptied.
3. Regular checks by Caretakers minimise risk of waste accumulation.
