# Fire Risk Assessment

## Hill House 1- 16

**Oakfield Close, Smethwick  
B66 3JU.**

**Date Completed: 4<sup>th</sup> June 2026**

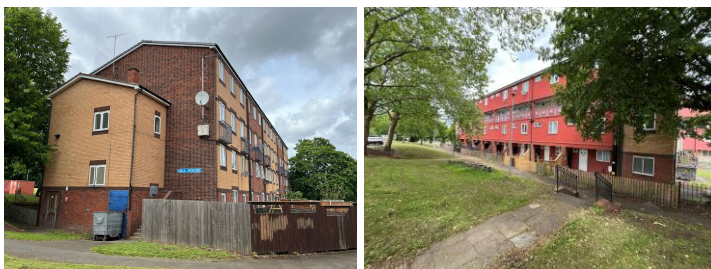
Front and rear elevation of the block.

Ground floor – Flats 1-8  
1<sup>ST</sup> floor – Flats 9 -16

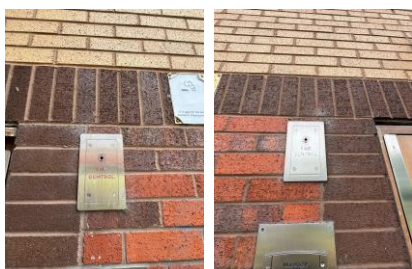
Firefighter's switches at both entrances

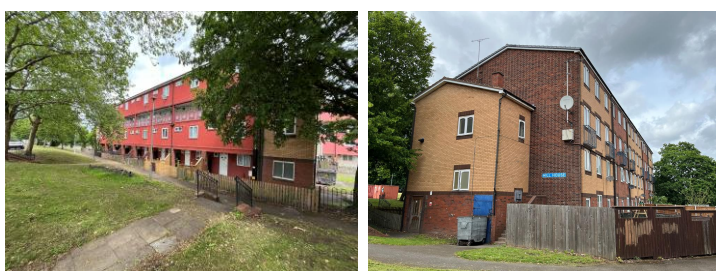
Externally the building has a timber fenced perimeter to the front and rear gardens of flats 1-8

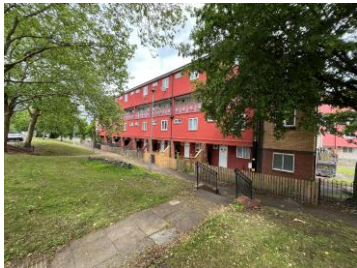
- 1) The building features a predominantly traditional cavity brick and concrete construction, topped with a flat roof and finished with UPVC under boarding along the roofline. Both access entrances are provided via a glazed timber door, situated to the either side of the block there are two dedicated refuse stores housed within a secure area, accessible via a locked timber and steel door.

Front Elevation

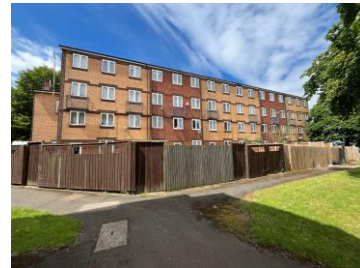
Both side and rear elevation

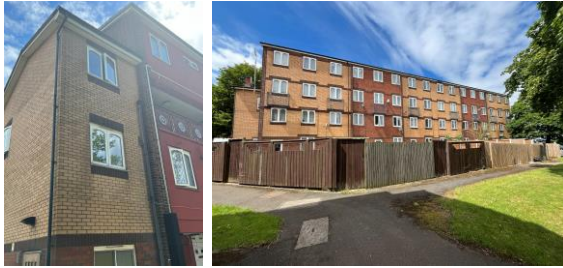
- 2) UPVC double glazed window units have been installed for each flat and communal areas within the block.

Communal and flat UPVC window units

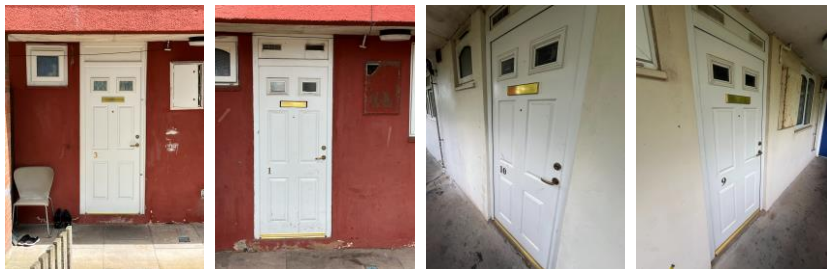
- 4) Residential flat entrance doors are composite doors FD30s doors, entrance to flats 1- 8 are positioned on the front elevation and open directly into the open air. Dwellings on the first floors are accessed via an external open deck; the first-floor open deck access is installed with steel railings measuring 1220 mm high. The communal stairwells are of concrete construction and are situated on both sides of the building.

Ground & 1<sup>st</sup> Floor flats entrance doors

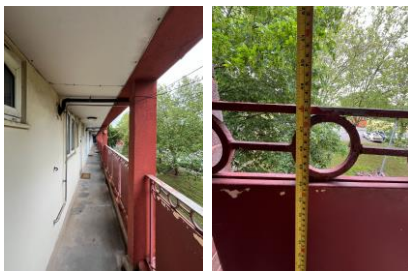
1<sup>st</sup> floor open deck railings

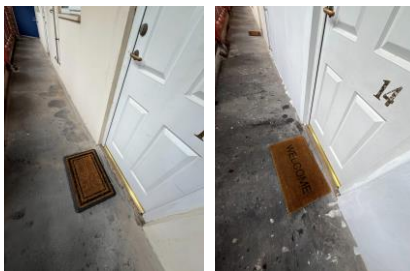
- 1) Each flat is equipped with, as a minimum LD3 fire detection to facilitate means of escape and provide sufficient response time.
- 2) Floor mats outside flats entrances are of acceptable size and condition.

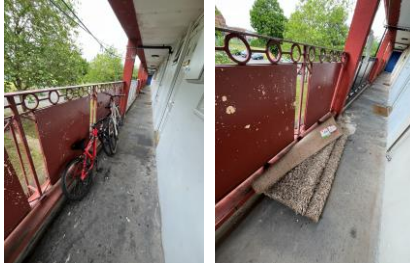
- 4) At the time conducting the fire risk assessment, it was evident that the open deck access has items of obstructions placed within it, 2 non-electric bicycles were chained up against the railing, and a rug was left on the deck walkway.

| Question/<br>Ref No | Required Action | Supporting photograph | Priority | Timescale<br>and Person<br>Responsible | Date<br>Completed |
|---|---|---|---|---|---|
| 7/4 | Obstruction on open deck access require removing. | | P2 | 1-3 Months<br>Housing<br>Manager | |

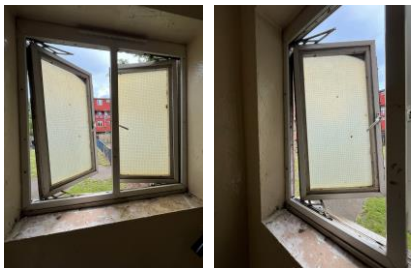
- 9) Damaged UPVC window unit within the communal stairwell landing. *An email has been sent to repairs on 17/06/2026*

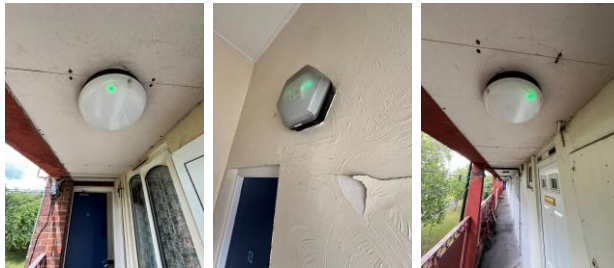
- 10) The block has dedicated emergency lighting system installed with standard lighting units situated throughout the communal stairwell, internal landings, and the open-deck access on the first floor. These units, supplemented by borrowed street lighting, provide sufficient levels of illumination to facilitate a safe means of escape.

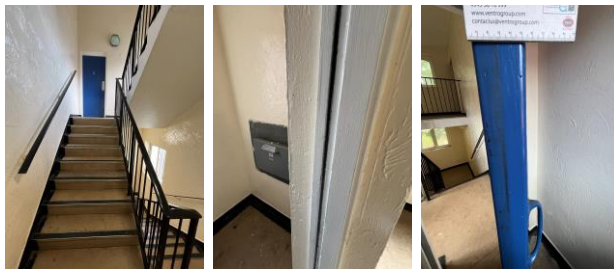
- 11) Bin chute rooms are located on the staircase landings at both ends of the block. Situated within the escape routes, these rooms are secured behind timber FD30S fire doors and present no risk to a safe evacuation.

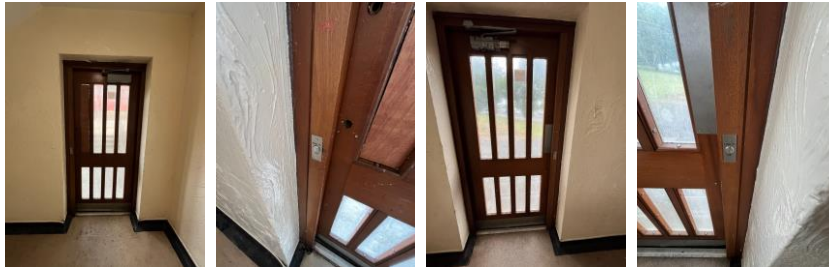
- 13) There is a clear and safe exit out of the building via the ground floor exits. The final front exit doors are made to fail safe in an emergency allowing smooth and safe evacuation.

Final exit doors and access release.

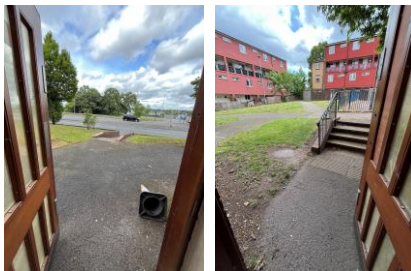
- 14) The route out the block to ultimate safety is clear from both final exit doors.

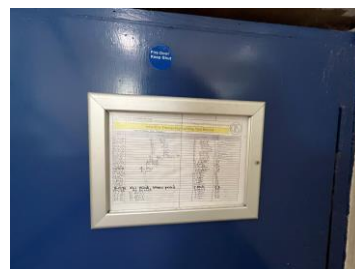
City Fire emergency lighting Cert and monthly test sheet.

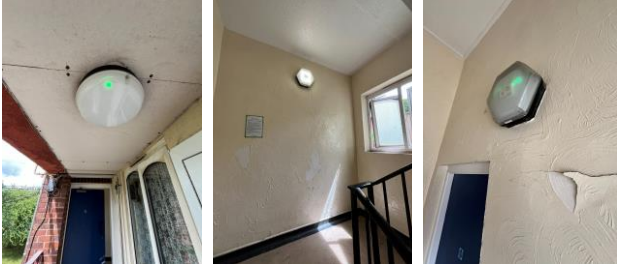
- 3) Emergency lighting is installed throughout the building; units are installed in communal areas e.g. stairways & corridors.

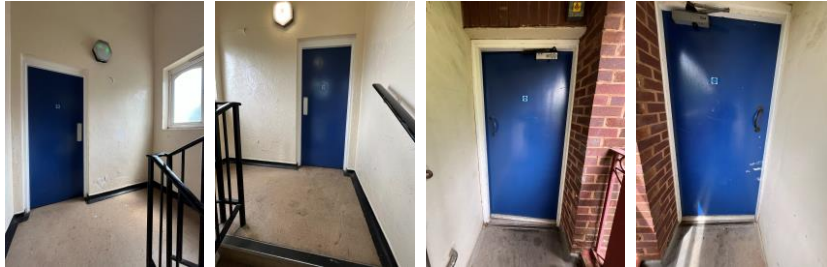
- 6) Both stairwells maintain sufficient compartmentation via FD30S fire doors equipped with self-closing devices, which control access from the landings to the open-deck walkways

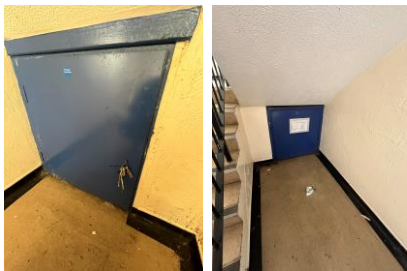
- 7) Electrical service cupboards on the ground floor under the stairs are locked and secured behind a steel door. It was not possible to access these cupboards to check firestopping and compartmentation. *FRA will be required to be updated when access is gained.*

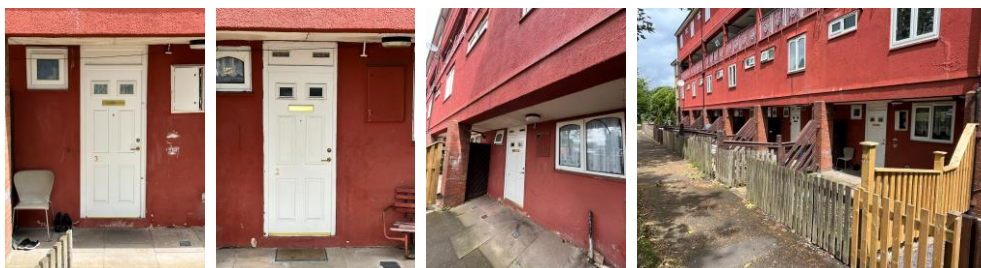
### Ground floor flats 1-8

- 8) While composite FD30s fire doors are fitted as standard to all flat entrance doors, exemptions apply based on specific escape route configurations. Ground-floor flats opening directly to fresh air with no vertical risk are exempt. First-floor flats opening onto open-deck access also do not require fire doors, as the availability of two-way travel sufficiently mitigates the risk. Compliance is further supported along these open deck access routes as all resident flat windows are set above the 1100mm threshold height from the finished floor level.

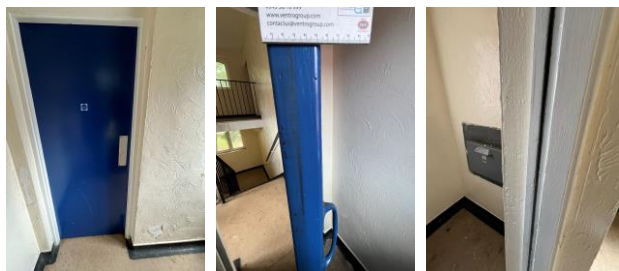
- 9) Both refuse chute rooms located in the stairwell landing are installed with timber FD30s fire doors, with self closing devices. The self closing devices were inspected and checked for auto closure.

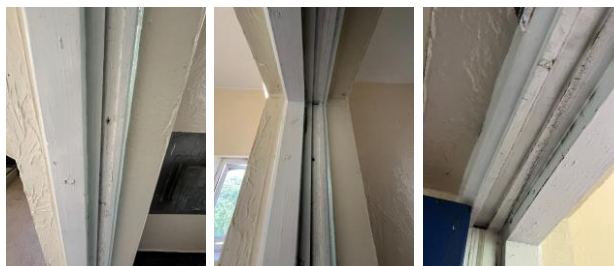
- 10) Refuse chute room door within the communal stairwell to the left entrance of the building has missing and damaged smoke seals.

| 10/10 | Refuse storeroom within the communal stairwell on the left entrance of the building. Reinstall seals and make safe. | | P2 | 1-3 Months<br>Fire Rapid<br>Response | |

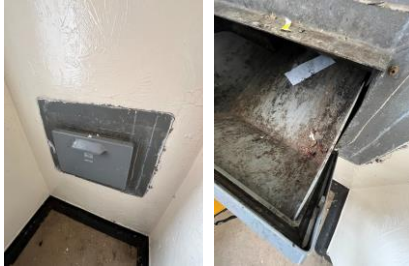
- 11) Intumescent seals have been installed within the chute hoppers located in both refuse chute rooms within the communal stairwell at either end of the block

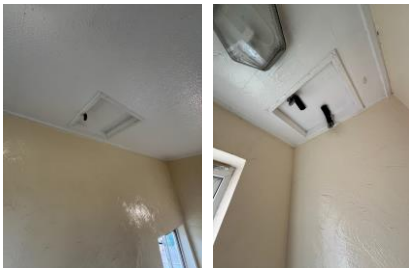
- 12) Roof access located on both 1<sup>st</sup> floor stairwell landings was not possible to gain access, the FRA will need to be updated once access is gained.

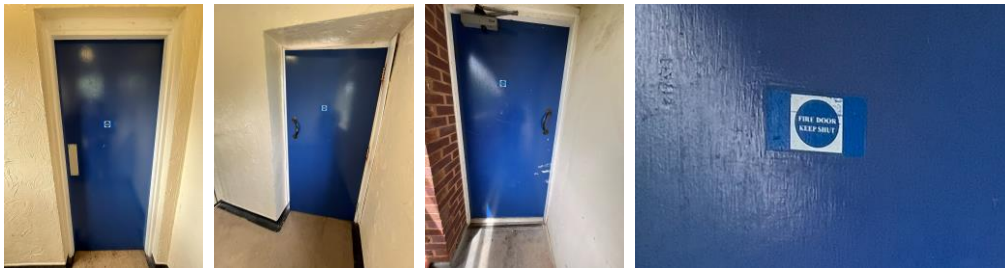
- 1) There are fire doors installed within the premise, these are found in the communal stairwell housing the refuse chute rooms and the access in both directions to the open deck access. Fire doors signage is evident on these doors.

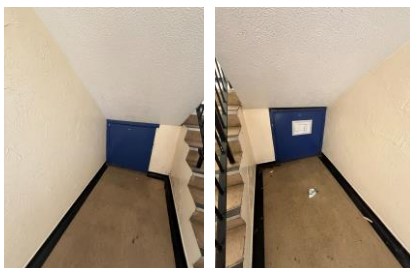
- 5) Electrical service cupboards on the ground floor under the stairs are locked and secured behind a steel door.

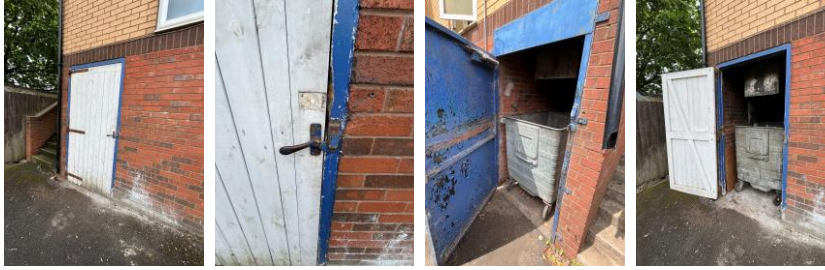
- 1) There is a regular Cleaning Service to the premises
- 2) Refuse bin are stored in secured bin rooms that are located at the side of the building. This is kept secure by a means of a levered handle. Bins Are regularly emptied by site services.

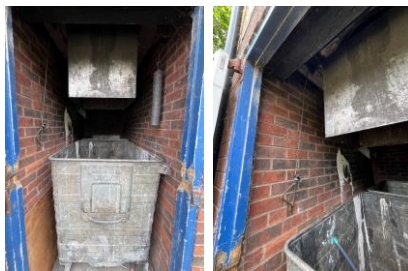
- 3) Refuse storage cupboard has a fusible link bin closure plate to mitigate any potential fire risk, both 1<sup>st</sup> floor internal refuse chutes are clear of any rubbish.

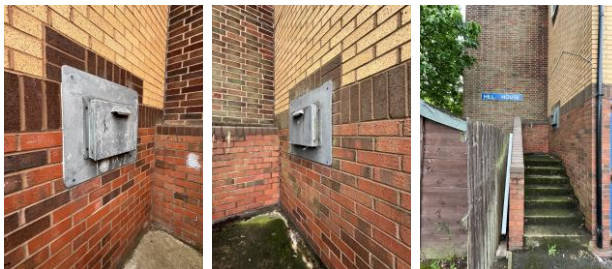
- 4) External refuse hoppers are installed on the side of the building near each entrance.

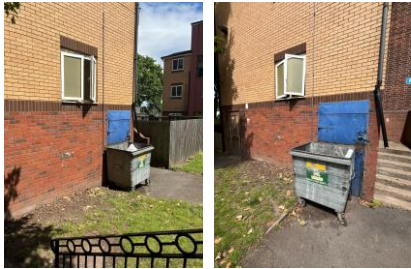
- 6) Refuse bin is stored outside external bin room and near to a communal area window unit.**

| 15/6 | Refuse bin is stored outside external bin room and near to a communal area window. Remove or relocate bin to a safe place to mitigate any risk to the building. | | P2 | 1-3 Months<br>Caretaking<br>Team | |

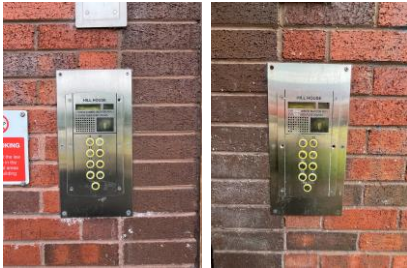
- 2) 1-16 Hill House has restricted access, this is via door access control, each resident has their own fob to gain access. There is an intercom system that can allow visitors and contractors in.

Both entrance door access systems.

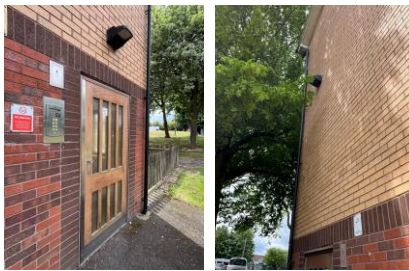
- 3) There is no current evidence of arson.
- 4) The perimeter of the premises is well illuminated. The building has external lighting units installed.

Lighting units above entrances to the block.

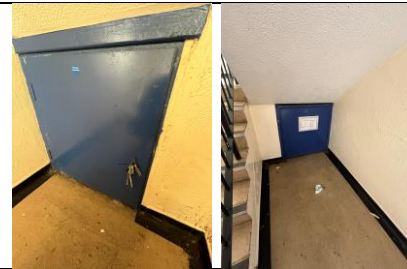
Electrical service cupboards on the ground floor under the stairs are locked and secured behind a steel door. It was not possible to access these cupboards to check firestopping and compartmentation. *FRA will be required to be updated when access is gained.*

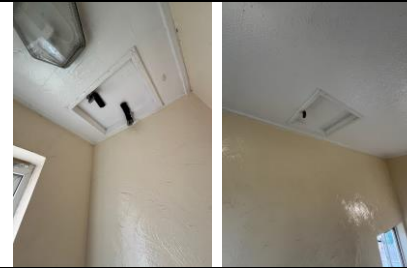
Access was not possible to gain to assess the roof void, the FRA will need to be updated once access to the roof void is gained.
