Fire Risk Assessment

Beaconview House

**Beaconview Road, West Bromwich,
B71 3PL**

Date Completed: 4th February 2026

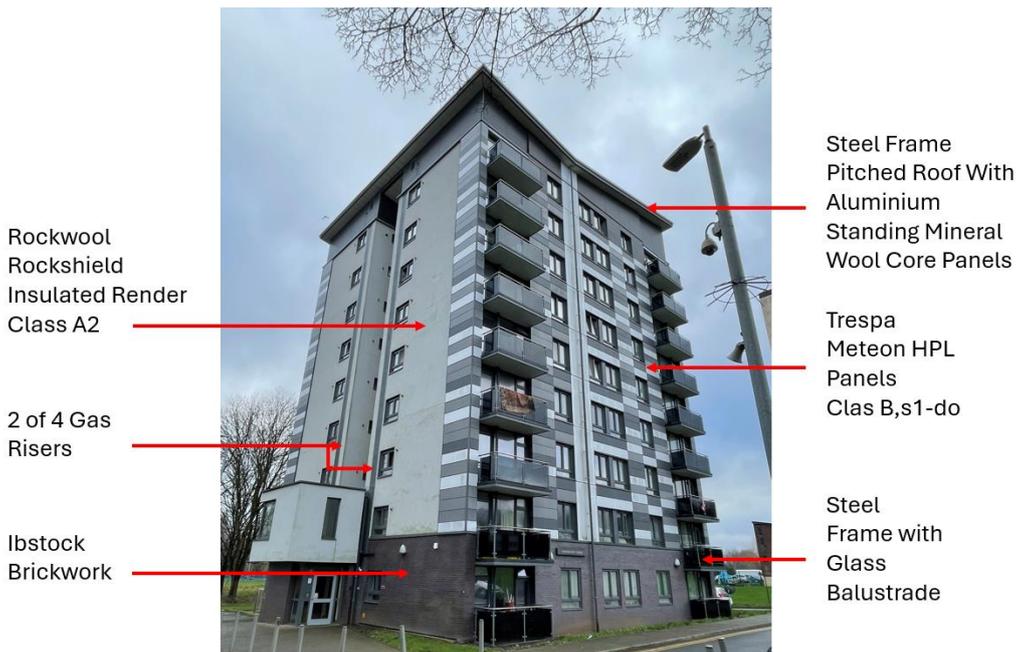
An FRAEW steps 2-5 was completed by Firntec on 30th May 2025. Based on the available evidence, the building presents an overall medium risk rating (neutral outcome). There are no recommended remedial actions within the report.

Below is a breakdown of the materials used within the external envelope and, as part of the external wall system of Beaconview House.

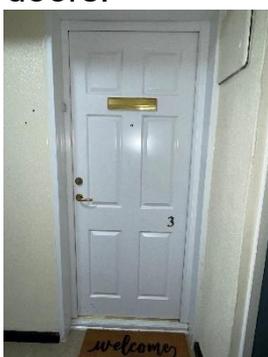
- 1) Individual flat entrance doors are nominal FD30S composite fire doors.

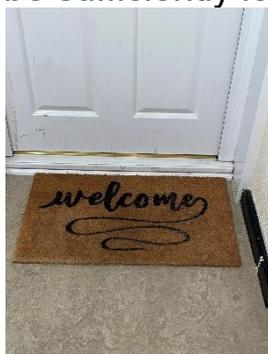
- 2) All flat entrance doors at Beaconview House are scheduled for an annual inspection in February 2026, on a best endeavour basis. The inspections and where necessary, any subsequent repairs or adjustments will be carried out by SMBC inhouse fire door inspectors / Fire Safety Rapid Response Team.
- 3) A number of flat entrance doors have door mats on the communal corridor side. The fire rating of the mats is unknown but deemed to be sufficiently low risk.

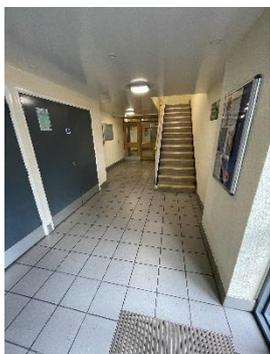
- 10) The communal lobbies and staircases are protected by use of nominal self-closing FD30s fire doors.

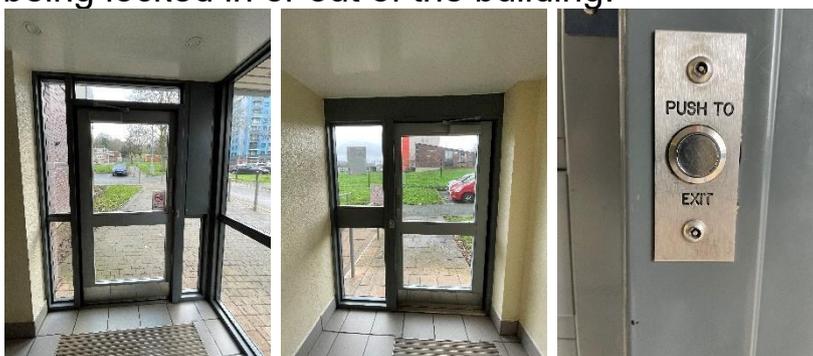
- 17) The final exit doors from the building have a door entry & exit system installed. These systems are designed to fail safe i.e., door unlocked in the event of a power failure. This prevents residents being locked in or out of the building.

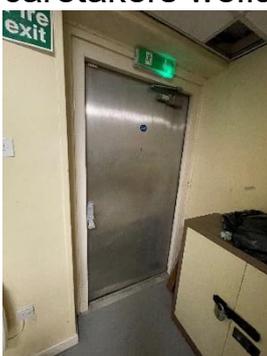
- 18) There is also final exit door equipped with a push pad from the caretakers welfare room.

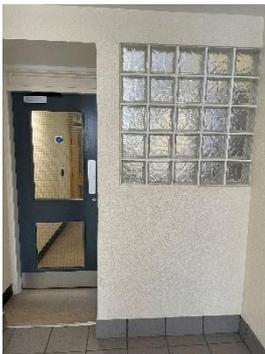
- 1) The building is designed to provide as a minimum 1-hour vertical fire resistance and 1-hour horizontal fire resistance around flats stairwells and lift shafts. All doors are minimum 30-minute fire resistant with cold smoke seals, including those in 1-hour rated walls.
- 2) Nominal 1-hour glass blocks form part of the wall between the protected stairwell and 1st floor viewing room. The blocks were installed during the 2015 refurbishment and are Weck Fire Glass blocks - 190x190x100mm supplied by Glass Block Technology to BS EN 1051-1 and anchored within a prefabricated aluminium frame.

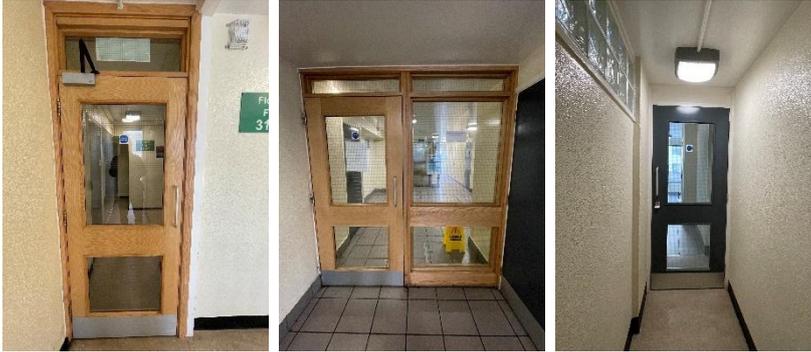
- 13) Communal fire doors within the means of escape are nominal FD30s doors with vision panels.

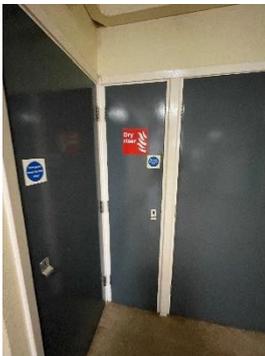
- 14) The dry riser cupboards are secured with locked nominal FD30s fire doors.

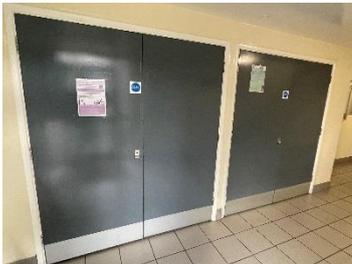
- 15) The service cupboards in this building are secured by locked nominal FD60s fire doors.

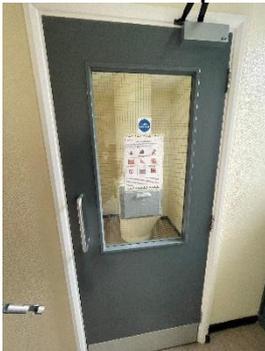
- 16) The doors to chute rooms are nominal FD30s with a Georgian wired vision panel.

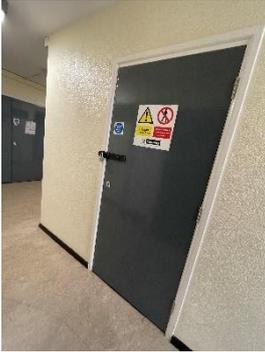
17) The lift motor room is secured with a locked nominal FD60s fire door.

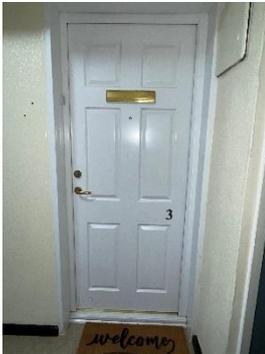
18) Individual flat entrance doors are nominal FD30S composite fire doors.

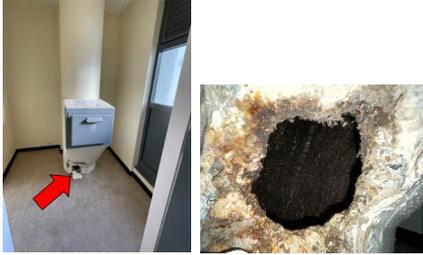
- 24) **The refuse chute system at 1st floor level has been damaged resulting in a hole approximately 100mm in diameter.** The risk is mitigated with an automatic closure plate and drencher system in the bin store, and the chute room is ventilated and has an FD30s timber door. However, the repair or replacement should be completed as soon as practically possible.

10/24	Hole in 1 st floor refuse chute to be repaired.

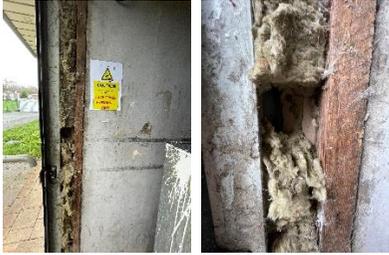
25) Reinstate mineral wool where missing where compartment wall ends in bin store.

P3	Within 3-6 Months Repairs	
10/25	Reinstate mineral wool where missing where compartment wall ends in bin store.
