Fire Risk Assessment

Hackwood House

**Hartlebury Road, Oldbury
B69 1EG**

Date Completed: 20/09/2022

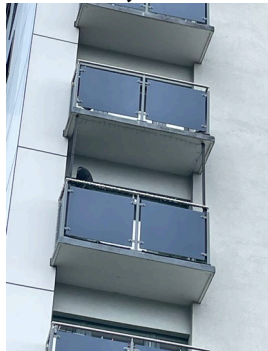
B. Flat 34, 6th floor has netting installed to balcony.

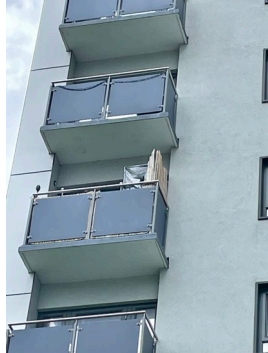
C. Flat 36, 6th floor has wicker screening to balcony.

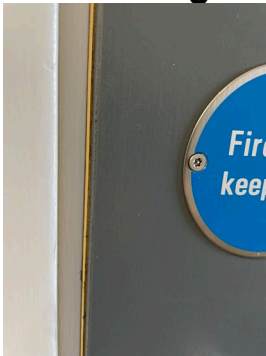
- 24) Door to chute room on 11th floor does not close fully into frame as light is visible between gaps.**

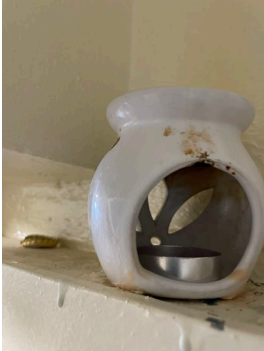
- 27) Tea light holder with tea light in communal landing area adjacent flat 58.**

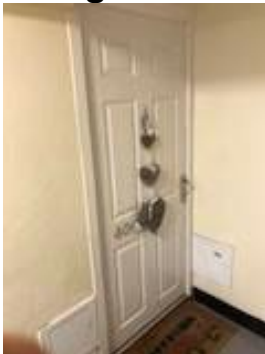
- 33) Decorative item has been hung on flat 40 entrance door, fire rating is unknown.**

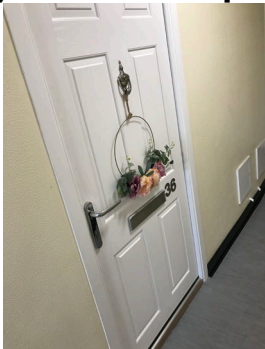
- 34) Decorative plastic flowers hung on flat 36 door.**

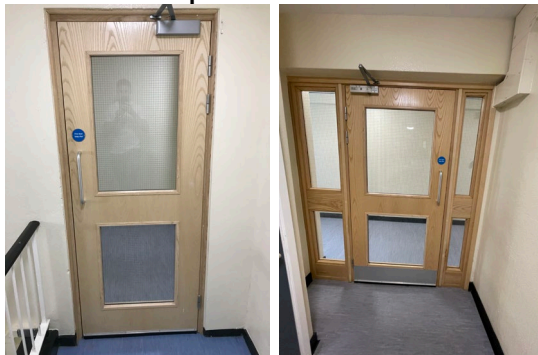
- 7) The corridors / staircases are protected by use of FD30s fire doors with vision panels.

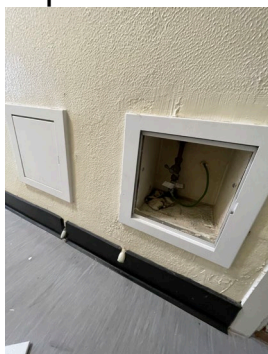
- 8) Access panels to stop taps are fixed to walls via timber rebate strips and found outside the flats of every floor.

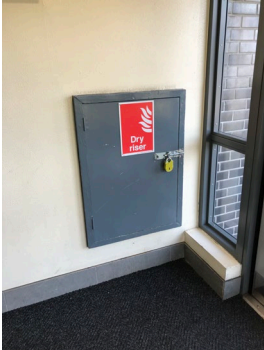
- 1) The dry riser inlet is located within the ground floor lobby, inside a dry riser cabinet and is secured with a firefighter's suited bridge padlock.

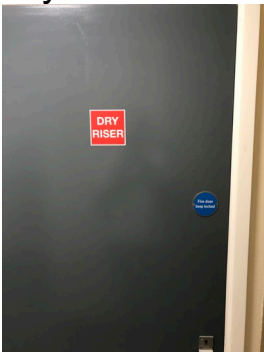
- 2) There is a dry riser that serves the building. The outlets are contained within a dry riser cupboard that is secured with a type 54 suited mortice lock

- 3) Dry Risers have sufficient signage

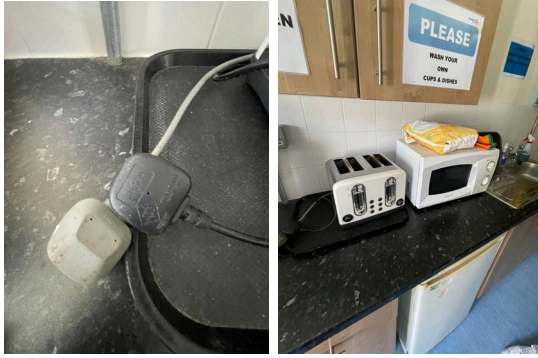
- 2) Hot working is not normally carried out. If essential maintenance requires the use of hot work processes, then corporate policies and procedures are to be followed.
- 3) Portable electrical equipment used as part of the Caretaking / Cleaning regime is subject to annual PAT Testing. This information is held by the Estate Services Manager Bryan Low. **No evidence of PAT testing on some appliances located in the caretaking/cleaning teams staff room.**

14/03	Appliances used in the caretaker's room (Ground Floor) require pat testing.

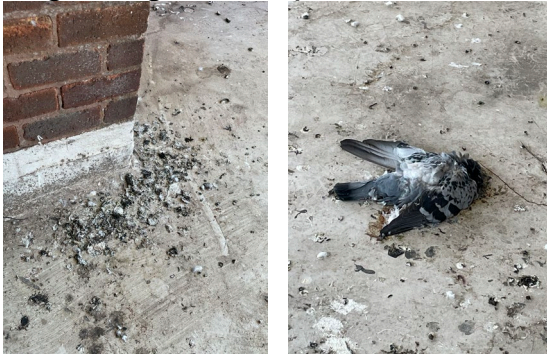
- 4) 'Out of Hours' service in place to remove bulk items.
 - 5) The enclosed roof area has a quantity of living and dead pigeons and a large build-up of excrement. It has been confirmed by the
-

team leader for fire safety & facilities that that an order has been raised for remedial works. Anticipated to commence week beginning 26th September 2022.

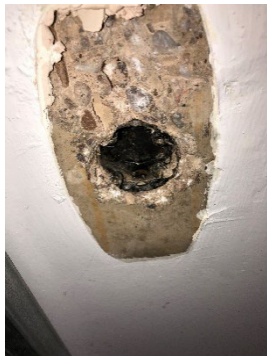
- 9) Hole in ceiling of external electrical / server room to be fire stopped. There are 2 additional holes within this hole running horizontally.

2	P2 Within 1-3 months of assessment date. Fire Rapid Response JM9592828	13/10/2022
10/9	Hole in ceiling of external electrical / server room to be fire stopped
