# FIRE RISK APPRAISAL EXTERNAL WALLS

## BOWATER HOUSE

Moor Lane  
West Brom  
B70 7AW

03/03/2026, James Major (Facade Manager)

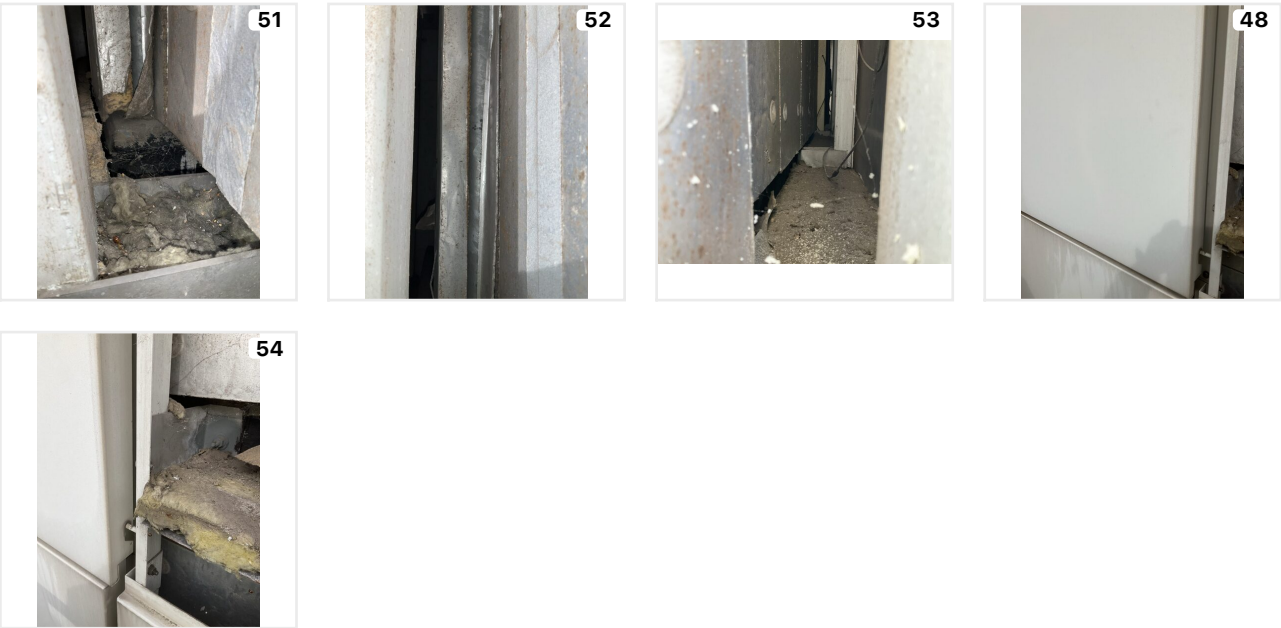
## Inspection Photos

Elevation • Location  
South Elevation • Cladding/PV Panel Interface
