# FIRE RISK APPRAISAL EXTERNAL WALLS

## HERONVILLE HOUSE

Sedgeley Road East  
Tipton  
DY4 7TX

RB-H4KUCU

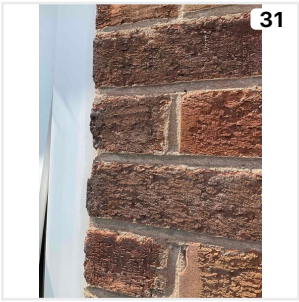
# Inspection: UNBKSV

Elevation • Location  
East Elevation • Compartment Floor and Wall Junction Interface
