Survey Date 13/08/2025

# FIRE RISK APPRAISAL EXTERNAL WALLS

## 1-32 HORTON STREET

1-32 Horton Street  
Tipton  
DY4 7JW

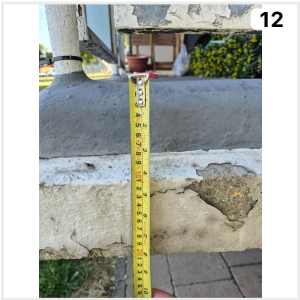
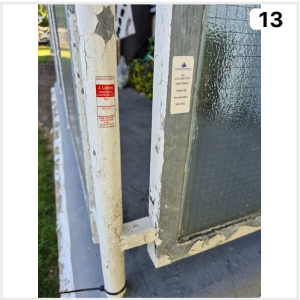
# Inspection: 3RZ4AK

Elevation • Location  
South Elevation • Compartment Floor Junction

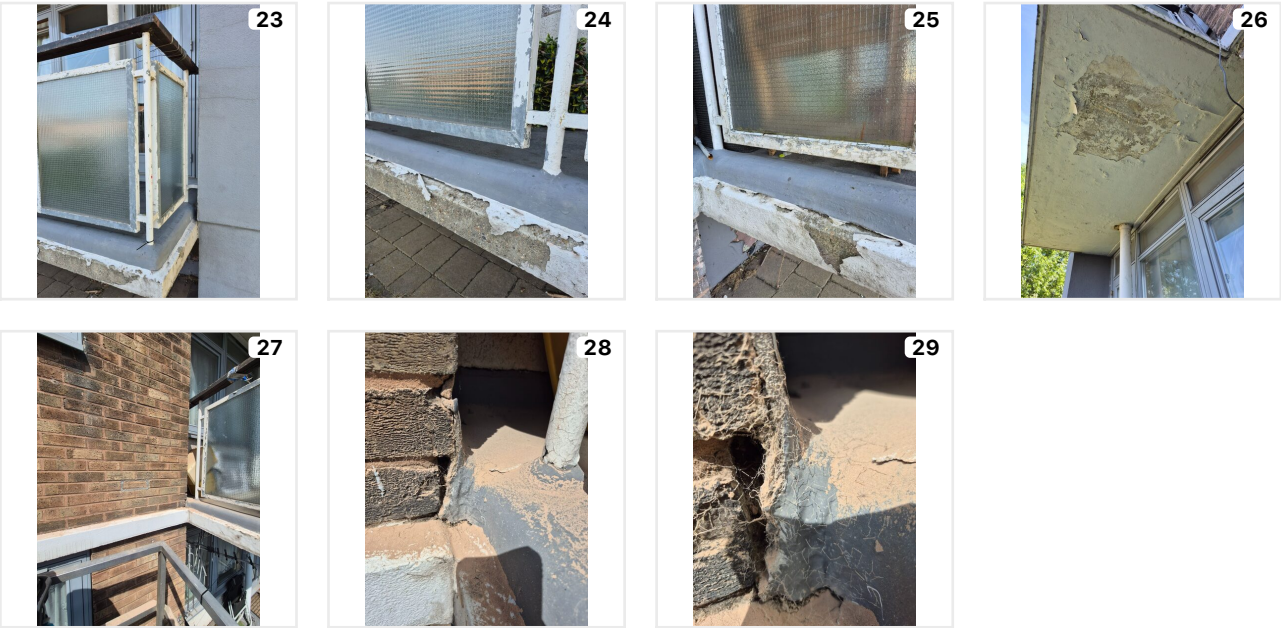
# Inspection: MTL1UD

Location  
Compartment Floor and Wall Junction Interface
