Document Version 1  
Survey Date 23/07/2025  
Suggested Review Date 23/07/2030

# EXTERNAL WALL SURVEY

## KYNASTON HOUSE

Kynaston House  
Rydding Lane  
West Brom  
B71 2HD

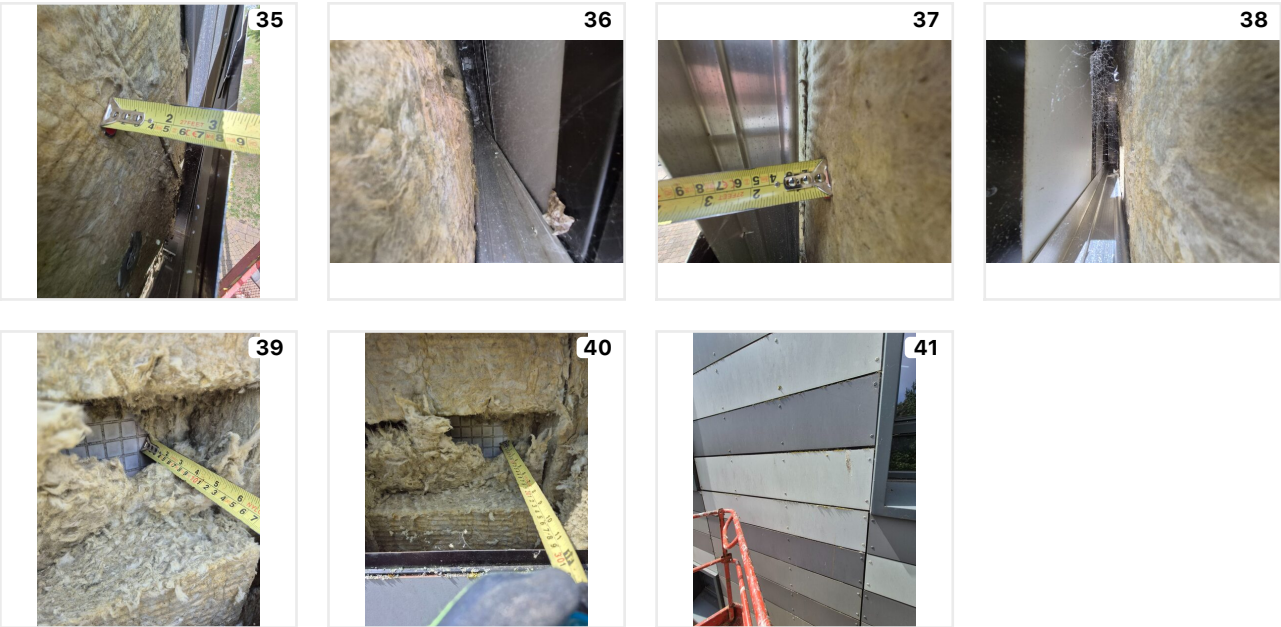
## Inspection Photos

Backing Wall Sits On The Floor Slab

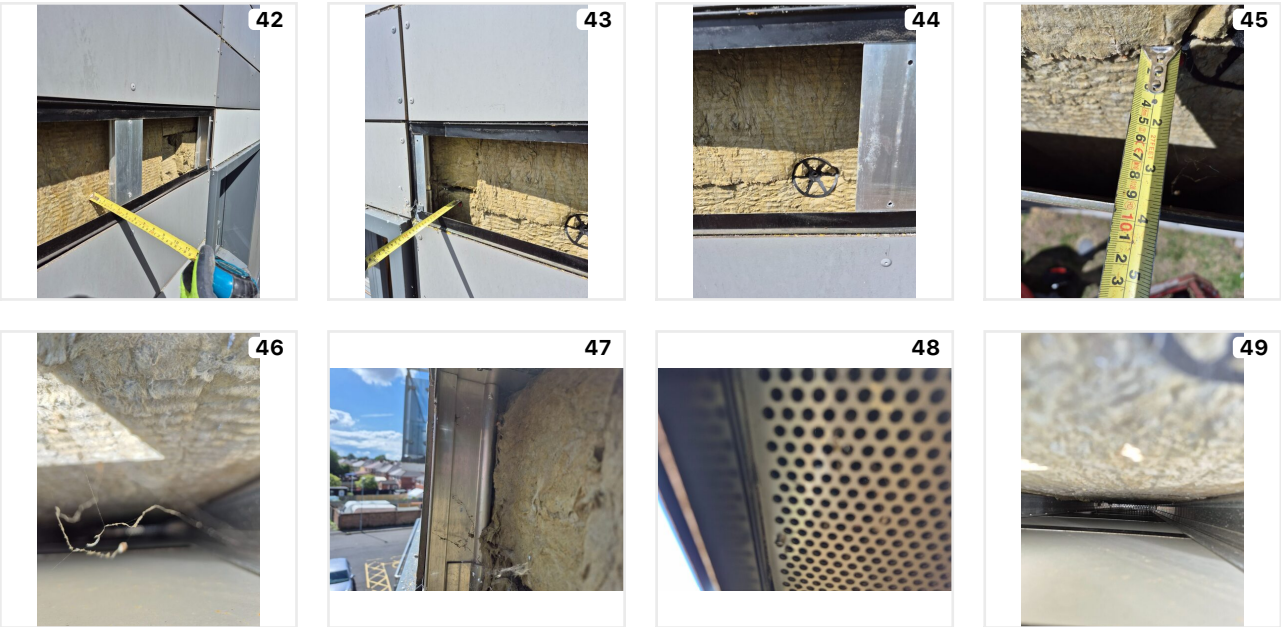
## Inspection Photos

Backing Wall Sits On The Floor Slab

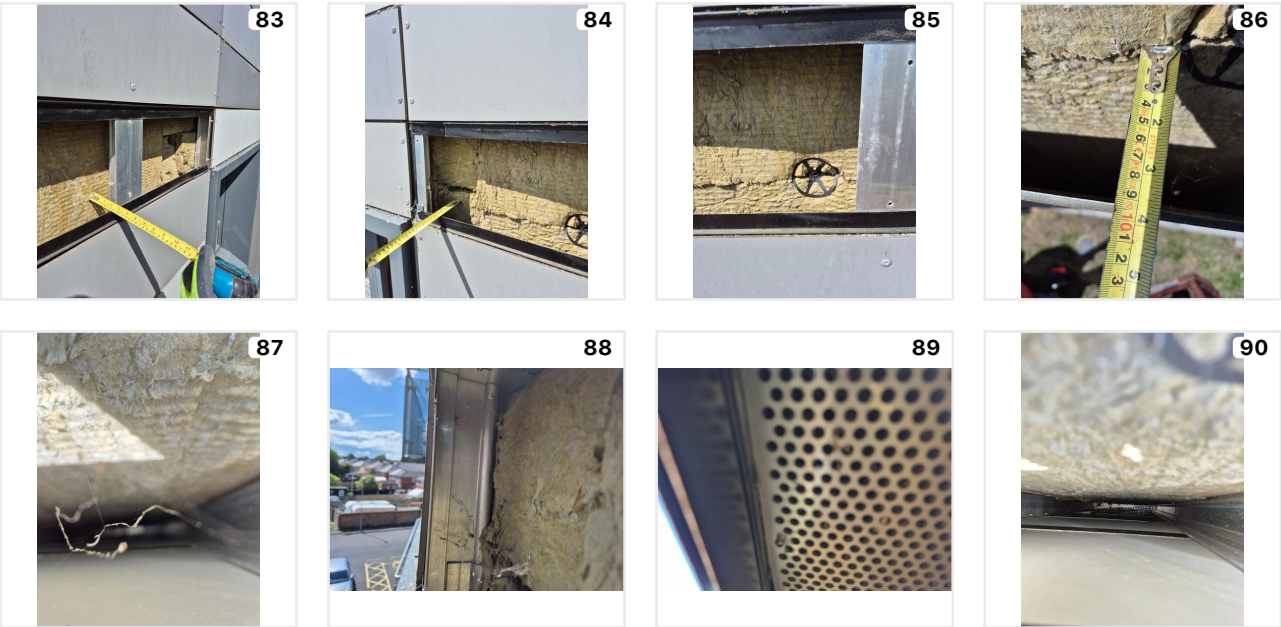
## Inspection Photos

Backing Wall Sits On The Floor Slab
