Document Version 3  
Survey Date 27/03/2025  
Suggested Review Date 27/03/2030

# FIRE RISK APPRAISAL EXTERNAL WALLS

## WIMBERGER HOUSE

Wimberger House  
Hallam Street  
West Brom  
B71 4HA

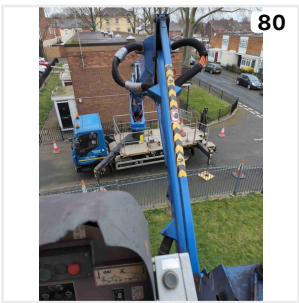
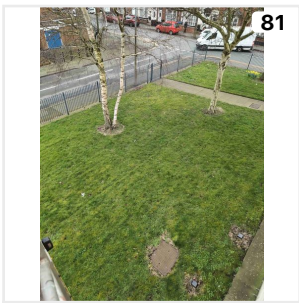
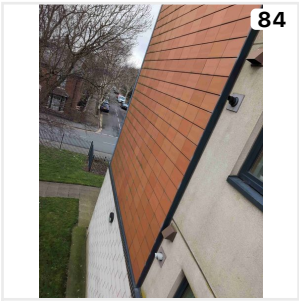
Unable to reach mewt on max reach

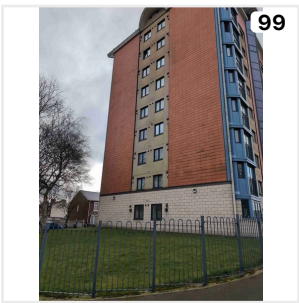
# Inspection: G35J75

Elevation • Location  
Inspection • Compartment Floor and Wall Junction Interface

Unable to reach with mewt, to high for ladders
