Document Version 1  
Survey Date 01/07/2025  
Suggested Review Date 01/07/2030

# EXTERNAL WALL SURVEY

## WYRLEY HOUSE

Sedgeley Road East  
Tipton  
DY4 7TT

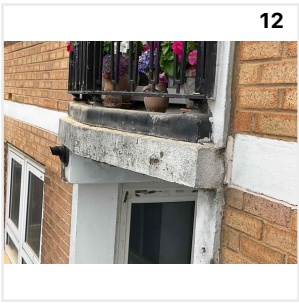
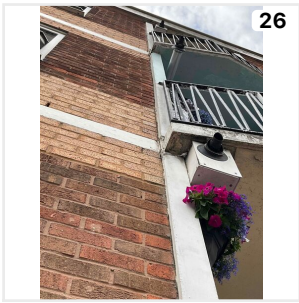
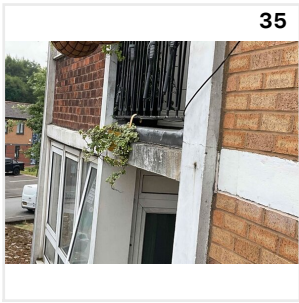
Visual observations only no access to private balconies
